**MONTGOMERY COLLEGE - OFFICE OF PROCUREMENT  
MACKLIN TOWER WRITING READING LEARNING CENTER RENOVATION, ROCKVILLE CAMPUS  
RFP NO.: 623-006  
RFP CLOSING DATE AND TIME: MAY 22, 2023 @ 2:00 PM**

**ADDENDUM #2  
ISSUED: MAY 16, 2023**

**APPENDIX D**  
**HOMOGENEOUS AREA PHOTO SHEET**

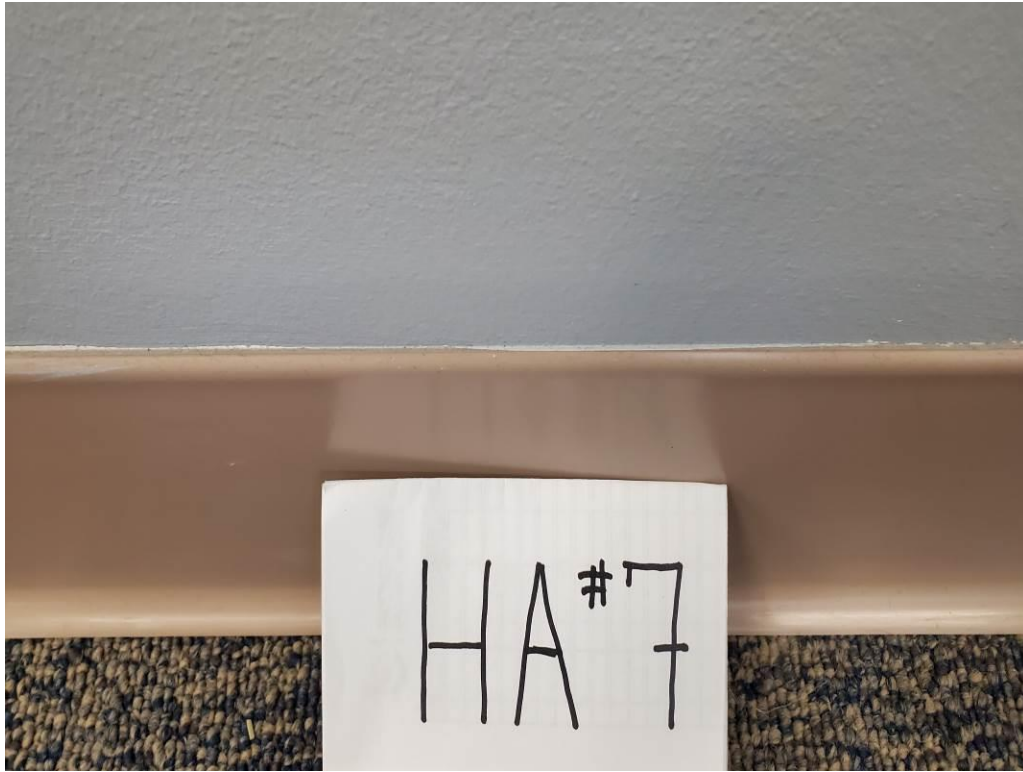
HA #7 – Tan Vinyl Cove Base w/ Mastic

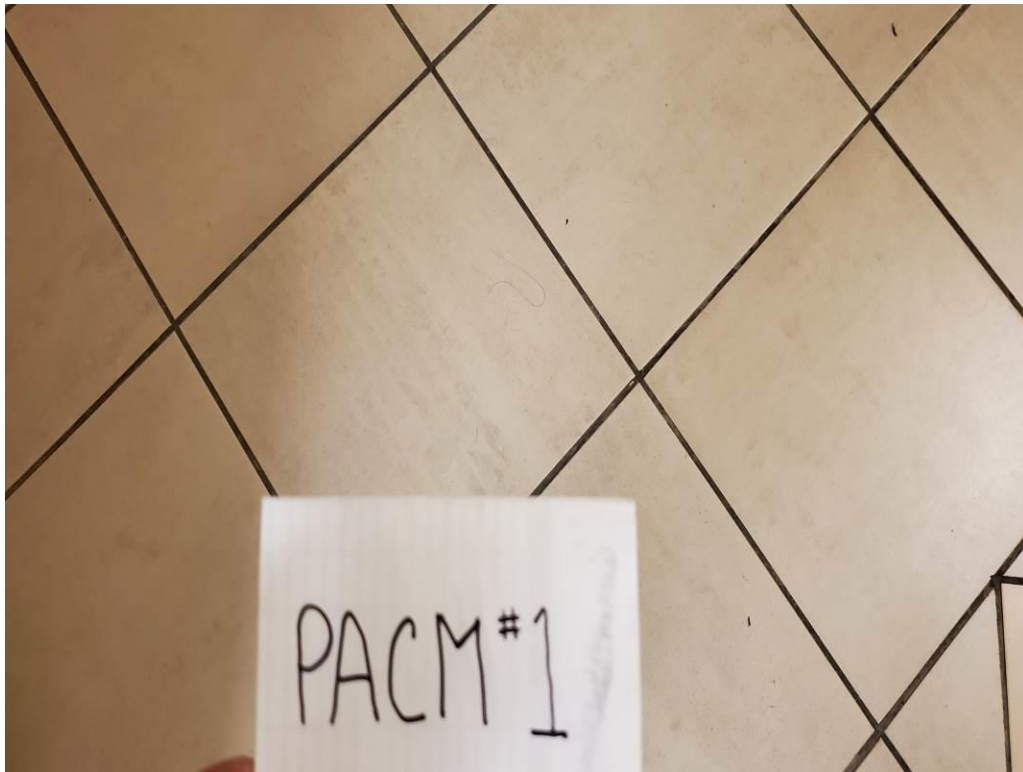
PACM #1 – 12”x12” Gray Ceramic Floor Tile Grout & Thinset

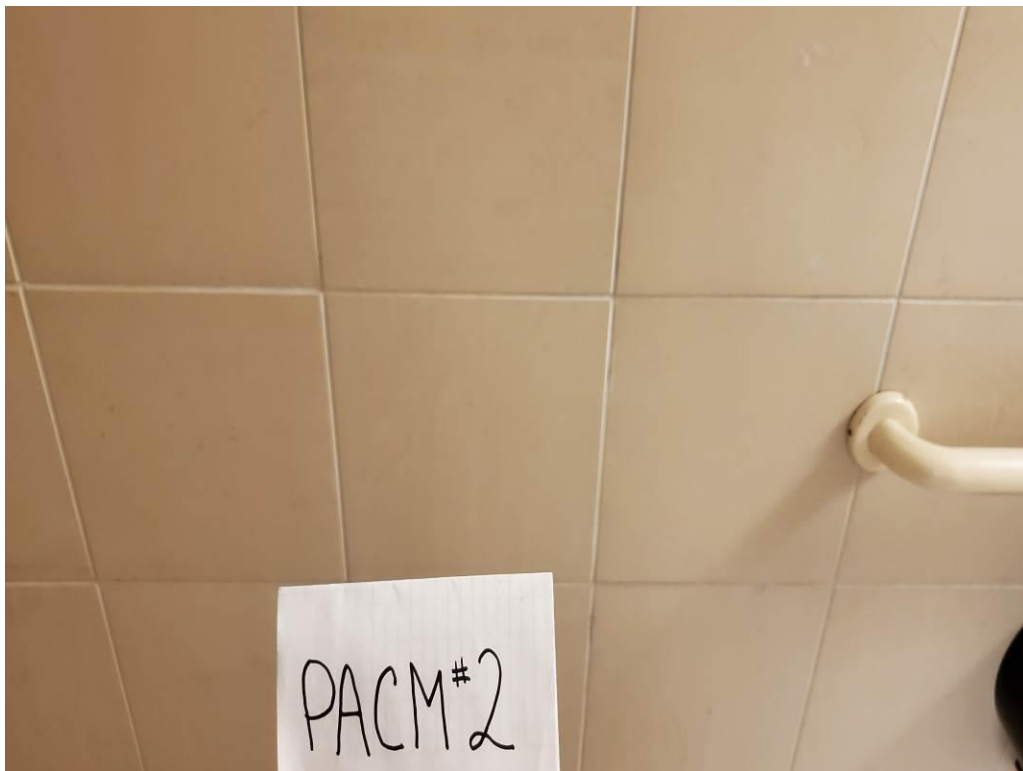
PACM #2 – 12”x12” Tan Ceramic Wall Tile Grout & Adhesive

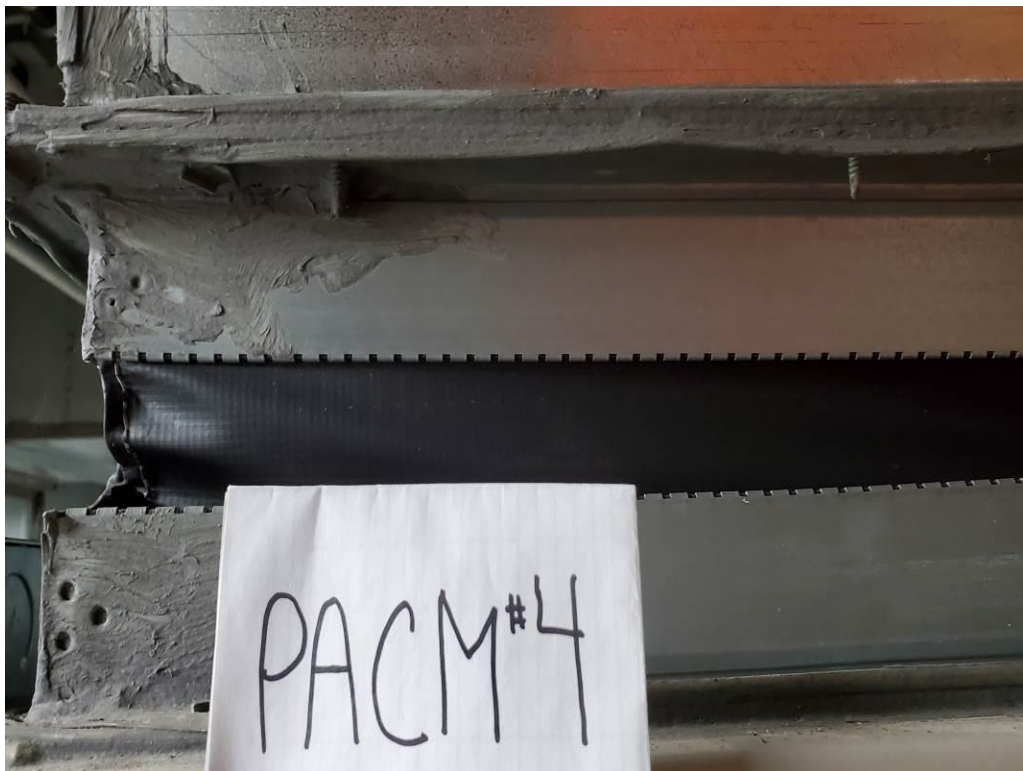
PACM #4 – Vibration dampening Cloth
