**MONTGOMERY COLLEGE - OFFICE OF PROCUREMENT
HIGH TECHNOLOGY AND SCIENCE CENTER ROOF REPLACEMENT AND FAÇADE REPAIRS
GERMANTOWN CAMPUS**

ADDENDUM #3

High Technology & Science Center, Building Enclosure Water Infiltration Investigation, July 27, 2023.

Project 230706 – Montgomery College High Technology & Science Center, Building Enclosure Water Infiltration Investigation, 20200 Observation Drive, Germantown, MD (MC Project #FP23-037, High Technology & Science Center (HT) Roof Replacement)

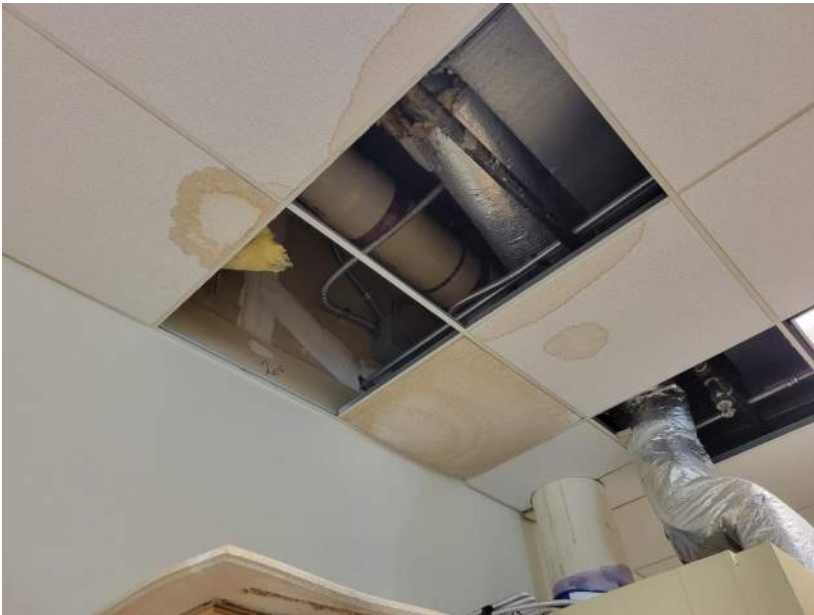
Photo 2

- Stains on ceiling tiles in Classroom 405, Seminar Room 216 (under the Auditorium roof), the second-floor lobby outside the auditorium, and several locations in the Atrium (Photos 2 and 3).
- Stains on the ceiling ties in Office 317. We removed the ceiling tile and observed an additional ceiling tile stacked on top of the stained ceiling tile. Using water-finding paper, we wiped the top surface of the second ceiling tile and the paper turned pink, confirming the presence of water. We identified the ceiling tile stack was directly below a primary drain leader of the Terrace Roof.
- Stains on the ceiling of the third-floor corridor that leads to the auditorium roof underneath the steep-slope roof-to-rising wall transition (Photo 4).

Classroom 405. Stained
ceiling tiles underneath
chemical hood duct
penetration.

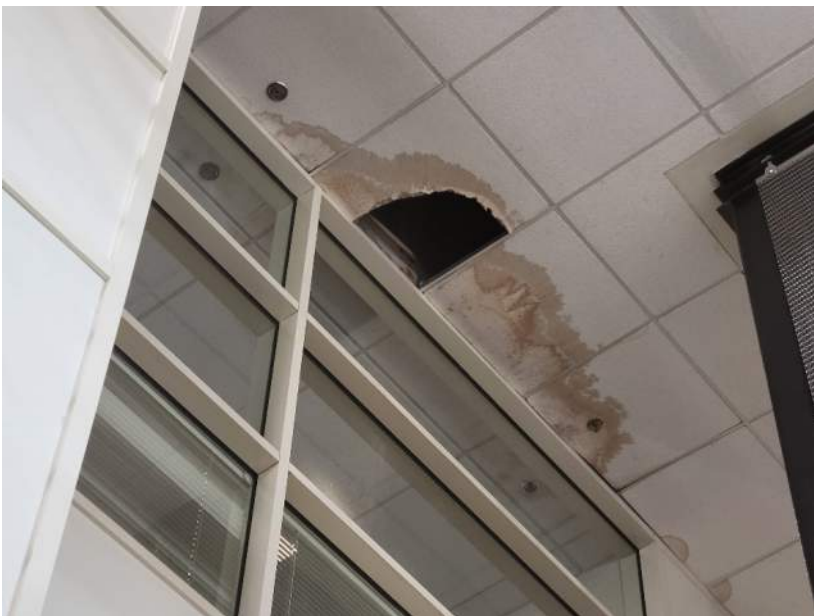
Photo 3

Outside Classroom 404.
Stained ceiling tiles near
new elevator.

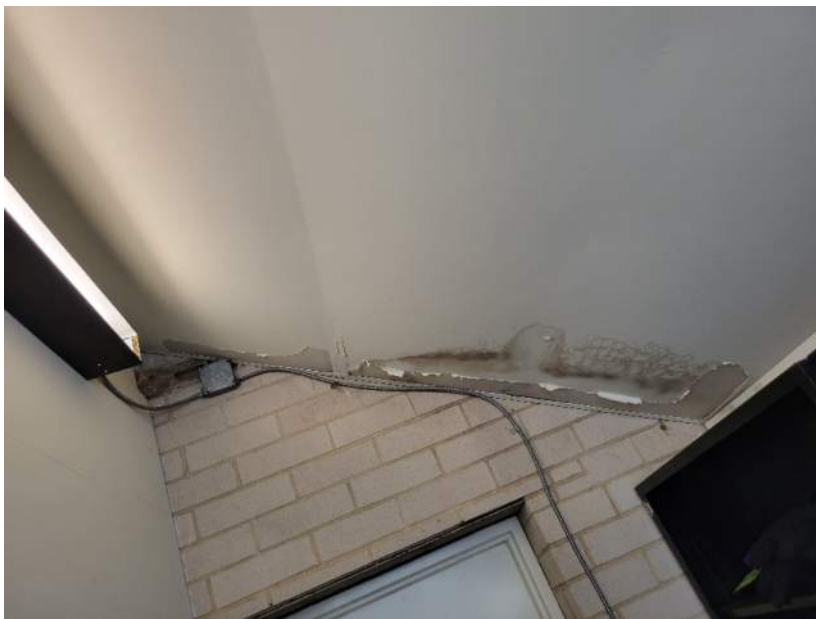
Photo 4

Auditorium Roof. Stains on the ceiling of the third-floor corridor underneath the steep-slope roof-to-rising wall transition.

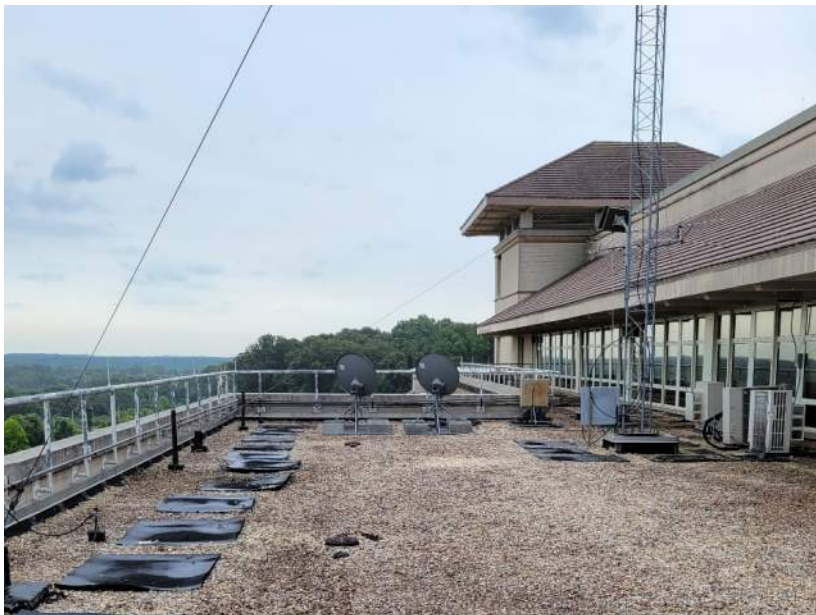
Photo 5

Terrace Roof. Rooftop equipment and penetrations.

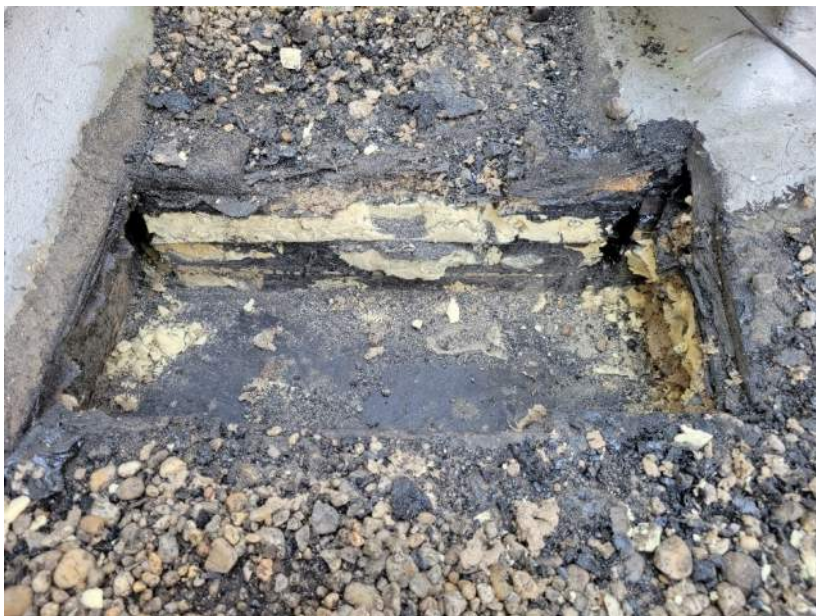
Photo 6

Main Roof, Opening 1:
Concrete fill over metal deck. 7.5 in. of insulation, 1 in. BUR.

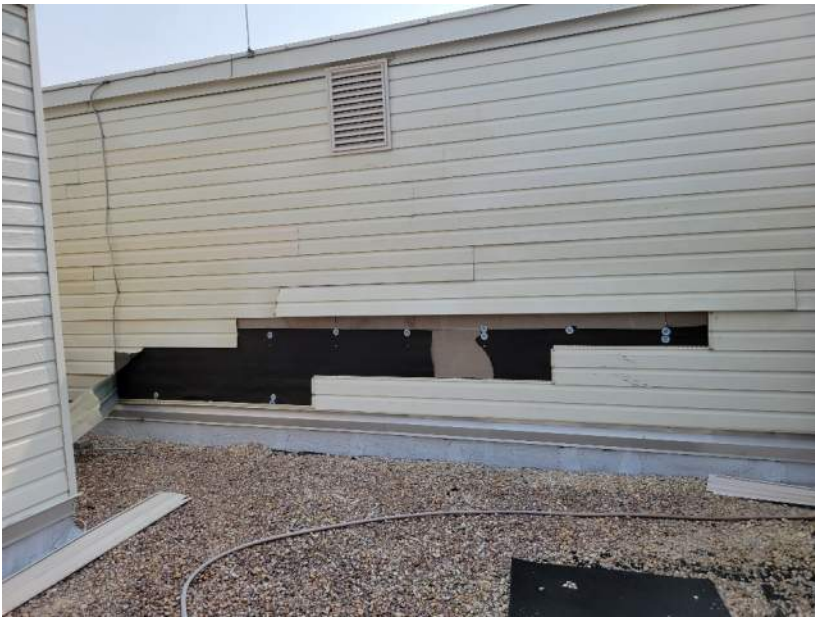
Photo 7

- Area of missing aluminum siding and building paper on the main roof. MC reported that the siding had been blown off the wall and pieces still remain on the roof (Photo 7).
- Staining on the back side of the gypsum sheathing in several locations (Photo 8).
- Staining on the back side of the gypsum sheathing at penetrations (Photo 9).
- Missing gypsum sheathing and building paper behind the aluminum siding (Photo 10).
- Staining on the steel studs (Photo 11).
- The bottom edge of the aluminum siding terminates with a continuous J-shaped metal flashing (Photo 12).

The aluminum siding is a rainscreen cladding and is designed to prevent bulk water from reaching the building paper, which forms the water barrier at the rising walls. Some of the siding had recently blown off, exposing the building paper and gypsum sheathing. We observed staining in several locations on the back side of the sheathing in both the Main and Auditorium crawlspaces, indicating breaches in the water barrier. We also observed locations of missing gypsum sheathing and building paper which create direct pathways for water intrusion. Though we are unable to confirm the exact leakage path, WT2, which sprayed water on the aluminum siding, created water intrusion on the interior under the penetration for the chemical hood vent (away from the wall). The aluminum-clad wall assembly could be allowing water to bypass the BUR termination and run beneath the roofing to enter the space below through the nearest penetration. Based on the original drawings, the exterior gypsum sheathing behind the aluminum siding is the substrate for the roofing termination. When water penetrates behind the building paper, it has a direct path behind the roofing termination and enter the roof assembly and building interior below.

Main Roof. Area of missing aluminum siding.

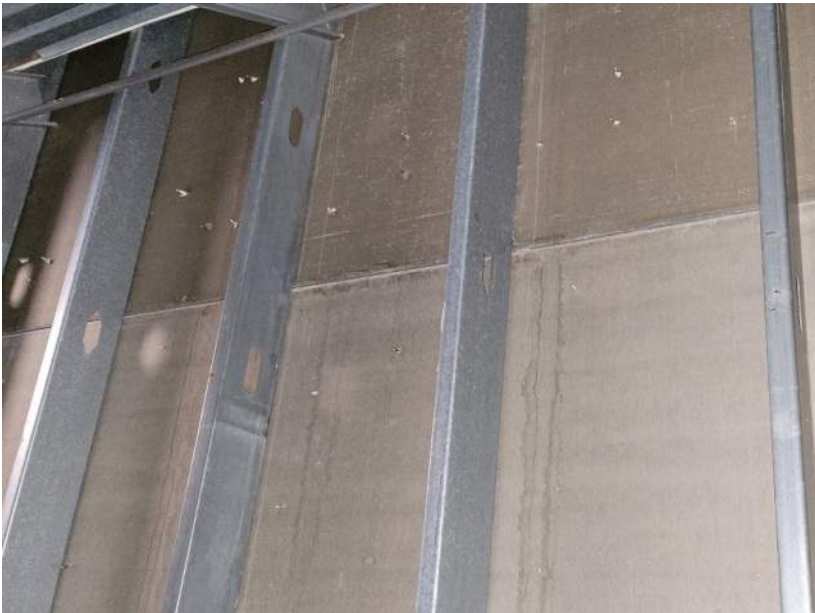
Photo 8

Auditorium Roof
Crawlspace. Staining on the
back side of the gypsum
sheathing.

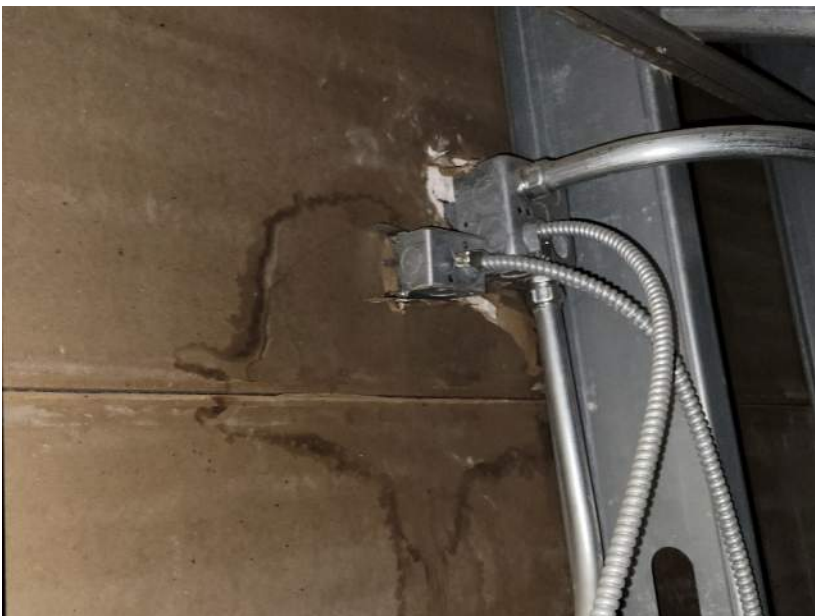
Photo 9

Main Roof Crawlspace.
Staining on the back side of
the gypsum sheathing at
penetrations.

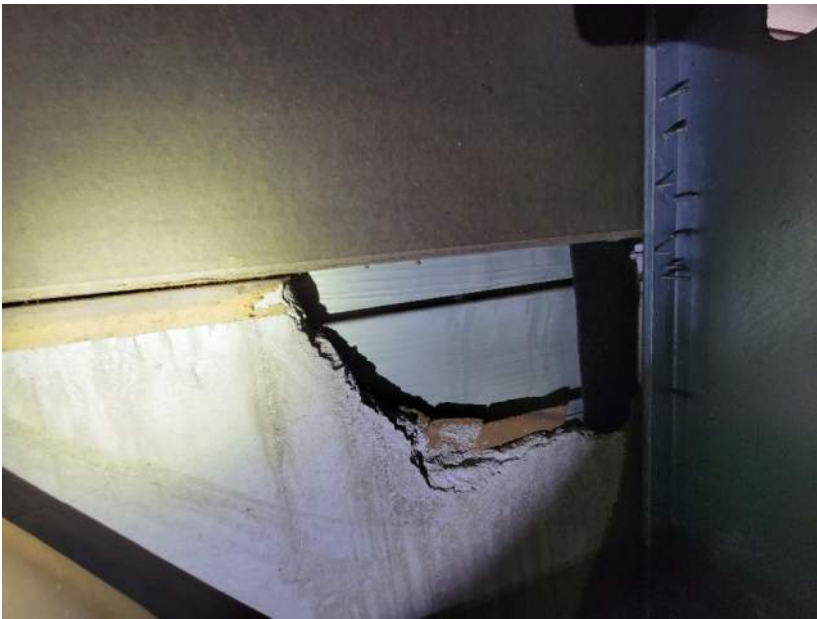
Photo 10

Main Roof Crawlspace.
Missing gypsum sheathing
behind the aluminum siding.

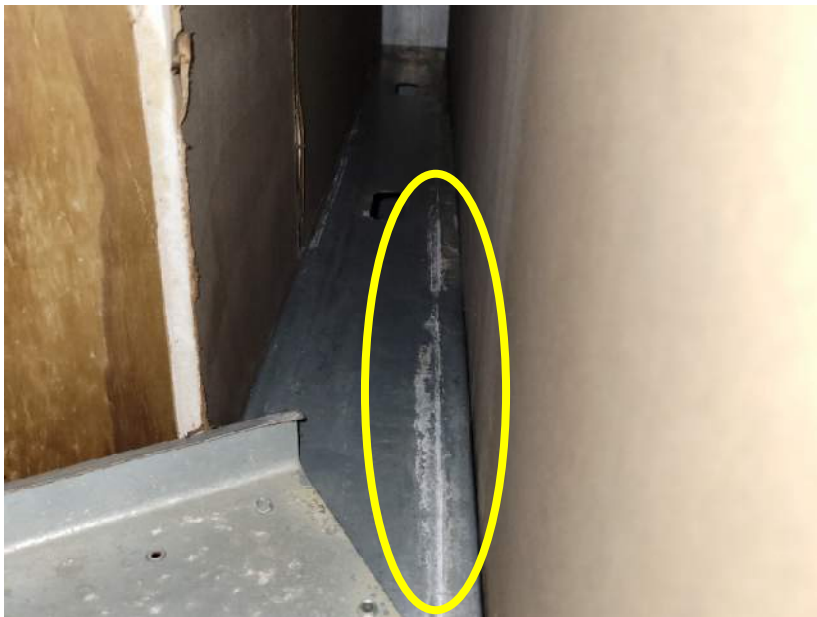
Photo 11

Main Roof Crawlspace.
Staining (circled) on the
steel studs.

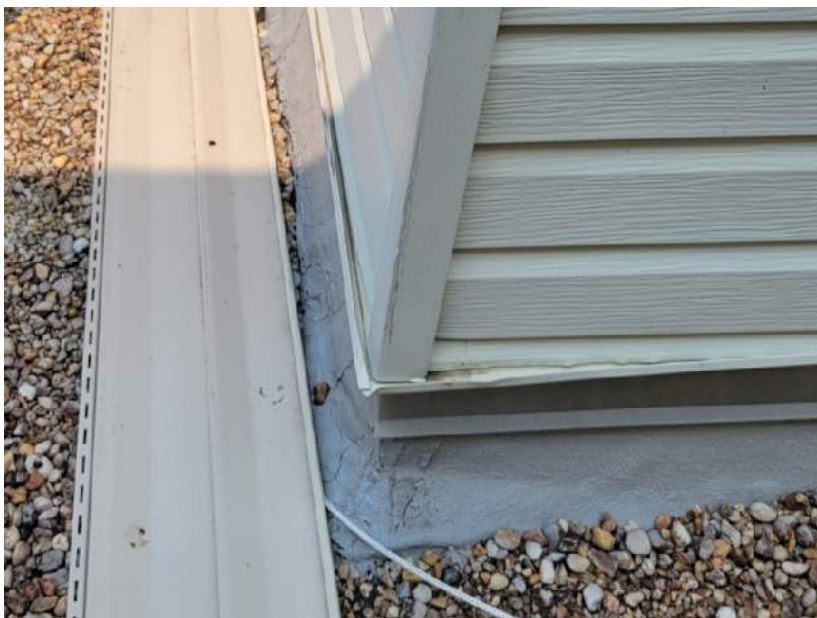
Photo 12

Main Roof. The bottom edge
of the aluminum siding is
captured by a continuous
J-shaped metal flashing.

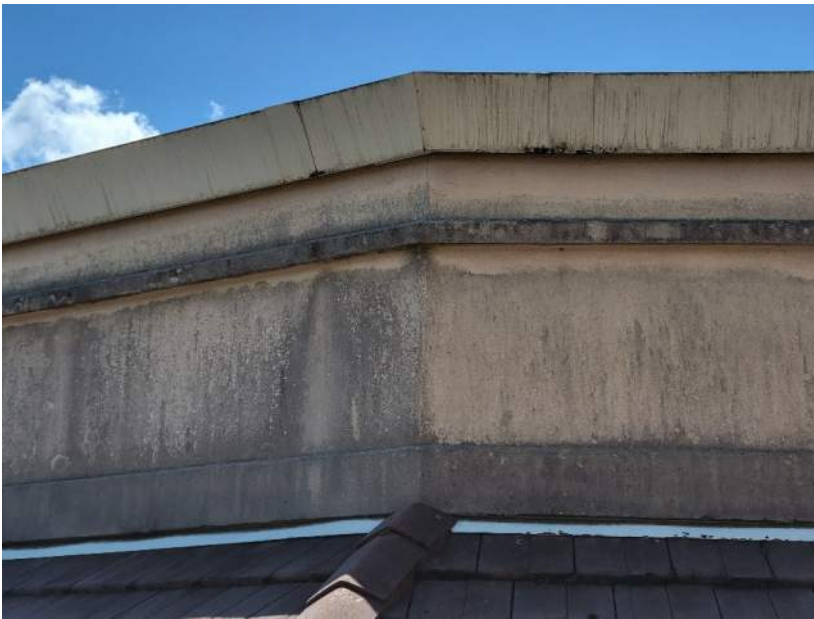
Photo 13

Auditorium Roof. Staining on EIFS.

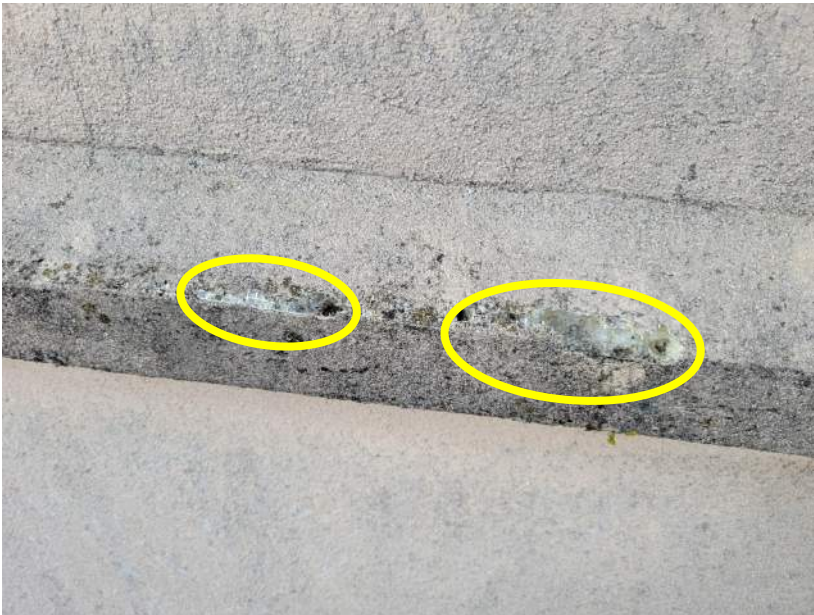
Photo 14

Auditorium Roof. Missing EIFS coating exposing the insulation (circled) at the upper decorative projecting band.

Installing a new high-temperature self-adhering membrane underneath the metal coping will provide the opportunity for continuity of the water barriers behind the new cladding at the roof side and the new drainage EIFS at the exterior. The expected service life of a new drainage EIFS cladding is likely twenty to thirty years with typical maintenance and may be extended with application of a coating toward the end of the timeline. A lower-cost approach (with corresponding lower durability and reliability) would be to repair the EIFS in place by filling cracks and recoating all of the EIFS with an elastomeric waterproofing coating. Continuity of the air/water barriers could still be provided by installing a new self-adhered flashing under the coping, lapped over the face of the EIFS. This approach may extend the service life of the barrier EIFS assembly a few years, but the coating will have to be inspected and maintained to maximize resistance against water ingress. Additionally, the barrier EIFS assembly will continue to be vulnerable to leakage should defects in the coating occur due to the lack of water-resistive barrier behind the EIFS.

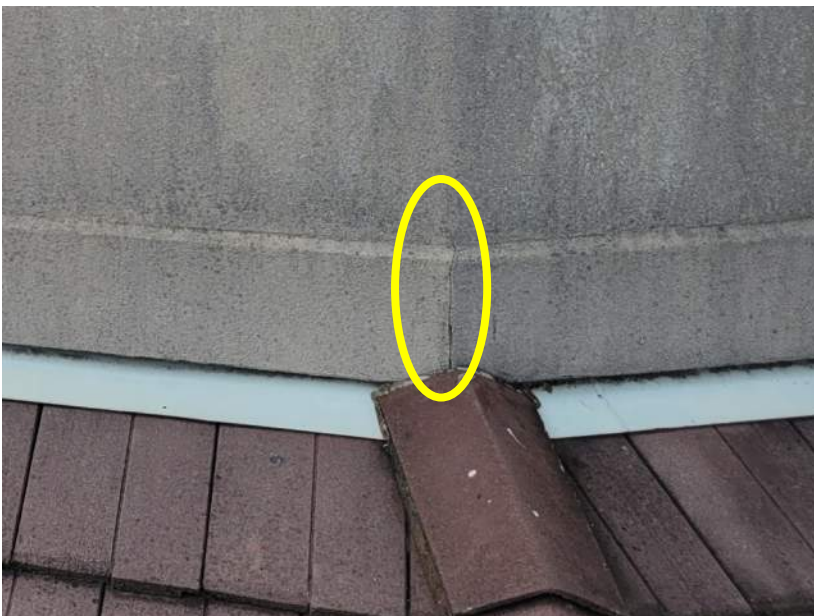
Photo 15

Auditorium Roof. Cracks in the EIFS coating at the lower decorative projecting band.

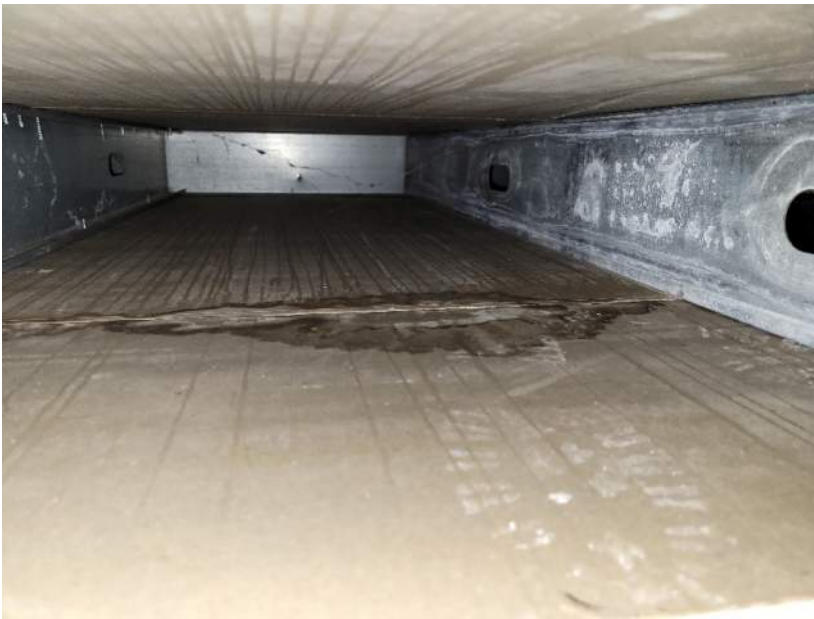
Photo 16

Main Roof Crawlspace.
Staining on the back side of
the gypsum sheathing
behind the EIFS.

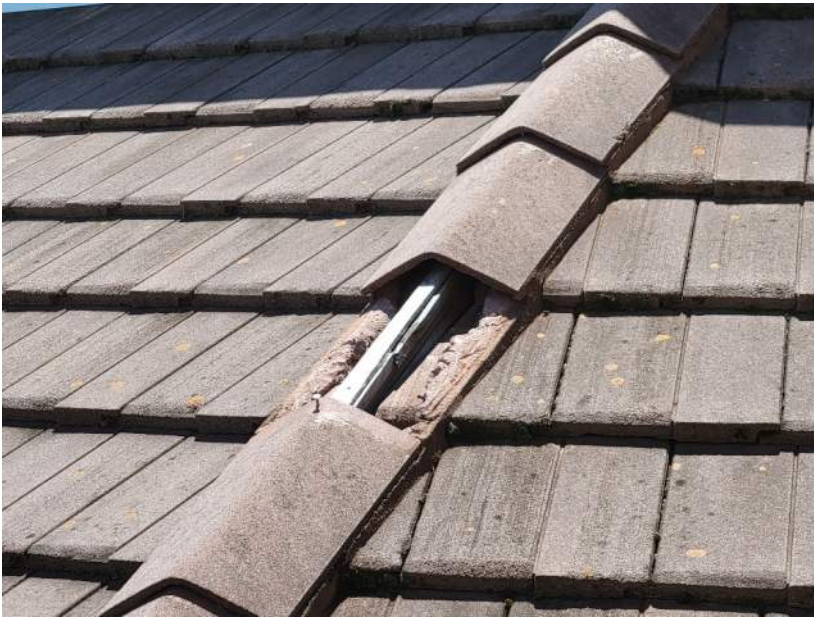
Photo 17

- Missing ridge tile on the Auditorium roof (Photo 17).
- Staining at isolated locations on the underside of the metal deck (Photo 18). It is unclear if the staining in this area is from construction or due to in-service leakage.
- Staining along light-gauge metal rafters supporting the metal deck (Photos 19).
- At the Auditorium roof to rising wall, we observed an approximately 2 in. gap between the steep-slope roof and the masonry veneer of the rising wall. The gap is covered by a reglet-set metal counterflashing set in a shallow slot cut in the face of brick masonry (Photo 20).
- With assistance from Western, we were able to remove and/or lift some concrete roof tiles and observe the condition of the roofing felt below. We noted the following:

Auditorium Roof. Missing
ridge tile.

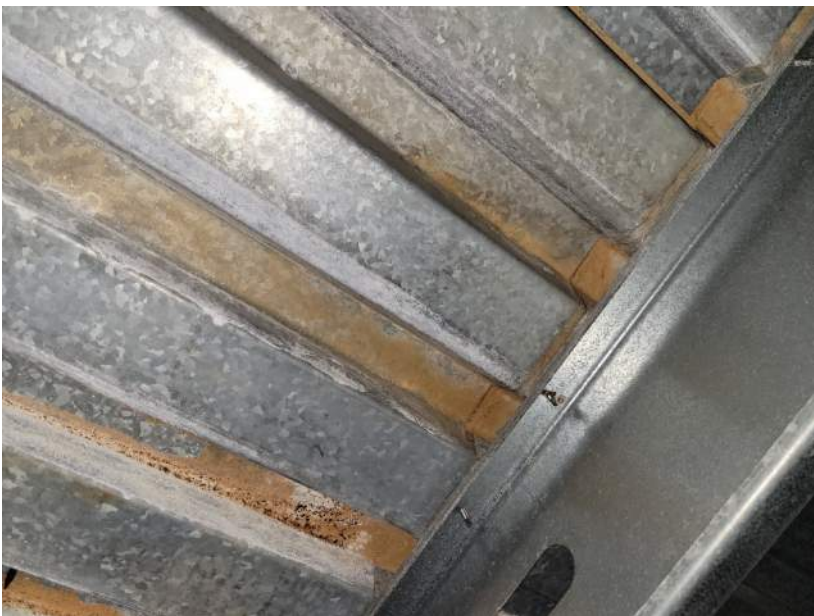
Photo 18

Main Roof Crawlspace.
Staining on the underside of
the metal deck.

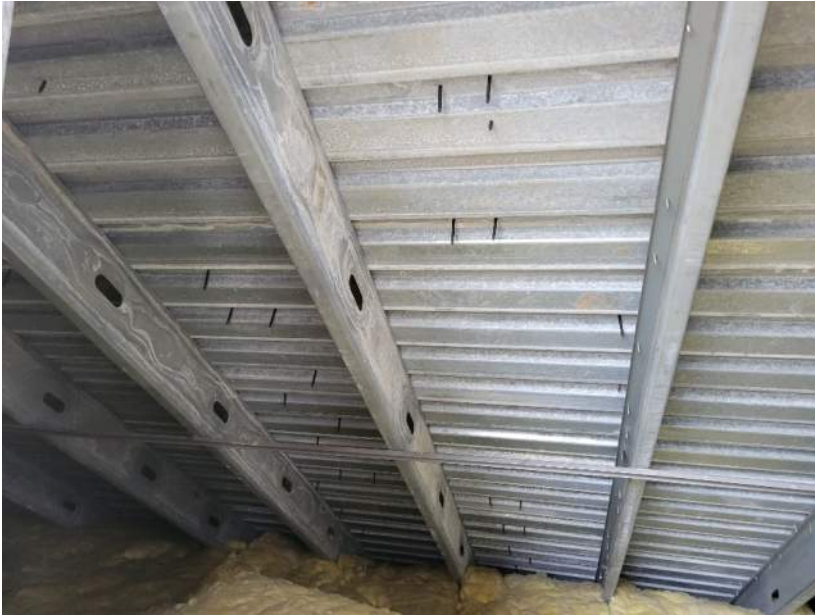
Photo 19

Main Roof Crawlspace.
Staining along metal studs
supporting the metal deck.

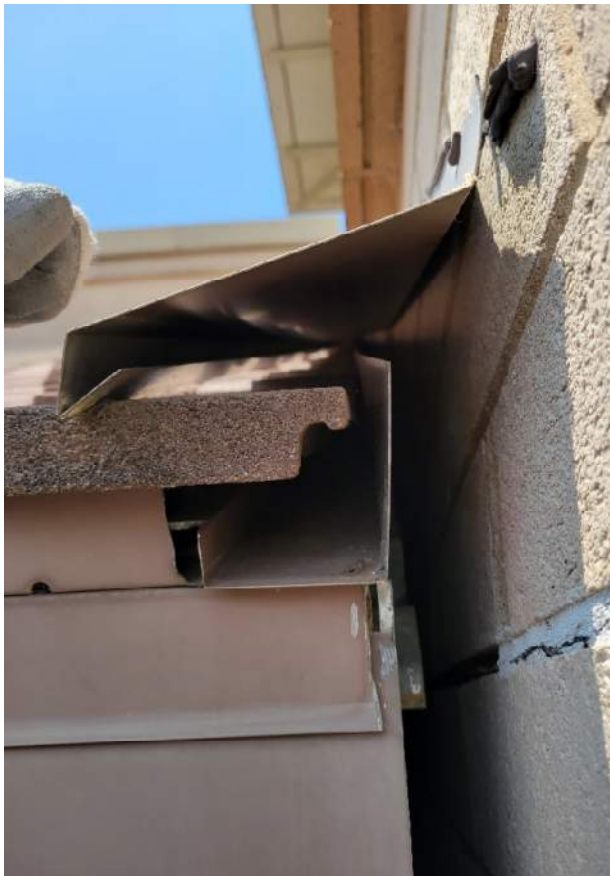
Photo 20

However, the transition of the steep-slope roof-to-rising tower wall contains a visible gap in the weather-resistive barrier, shows staining underneath, and leaked during our water testing. Detail A5/A6-2 provided in the original drawings shows a flexible expansion joint cover and gutter, neither of which were installed. Instead, only a reglet-set metal counterflashing covers the joint. This joint, and the corresponding joint on the west elevation (with slightly more complex geometry) will continue to leak unless a new expansion joint cover is installed. Proper integration with the porous brick masonry on the rising tower wall will require leg-and-leg removal of brick masonry to allow for installation of a through-wall flashing and roof counterflashing above the upturned roof termination.

Auditorium Roof.
Steep-slope roof-to-rising
wall transition.

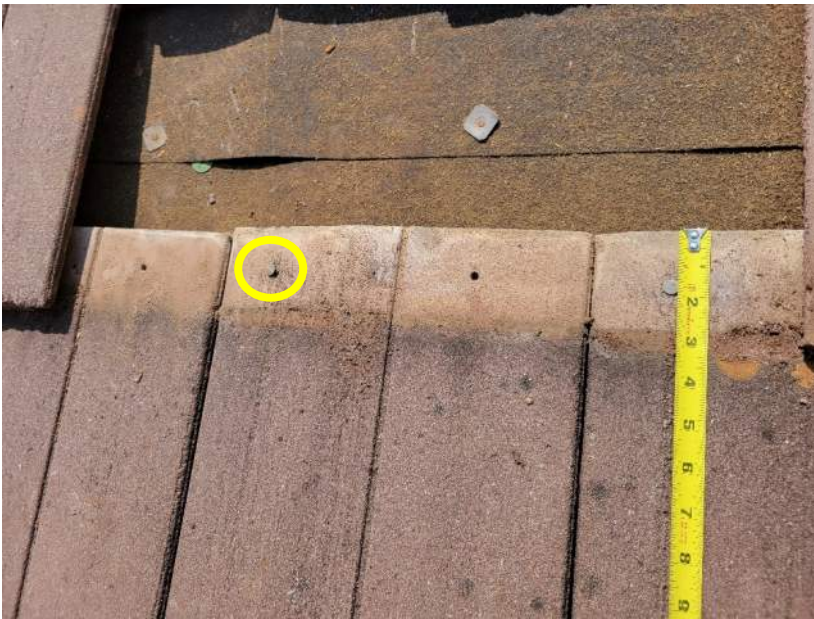
Photo 21

Auditorium Roof. Each concrete roof tile was secured with one nail (circled) fastened to the horizontal wood battens.

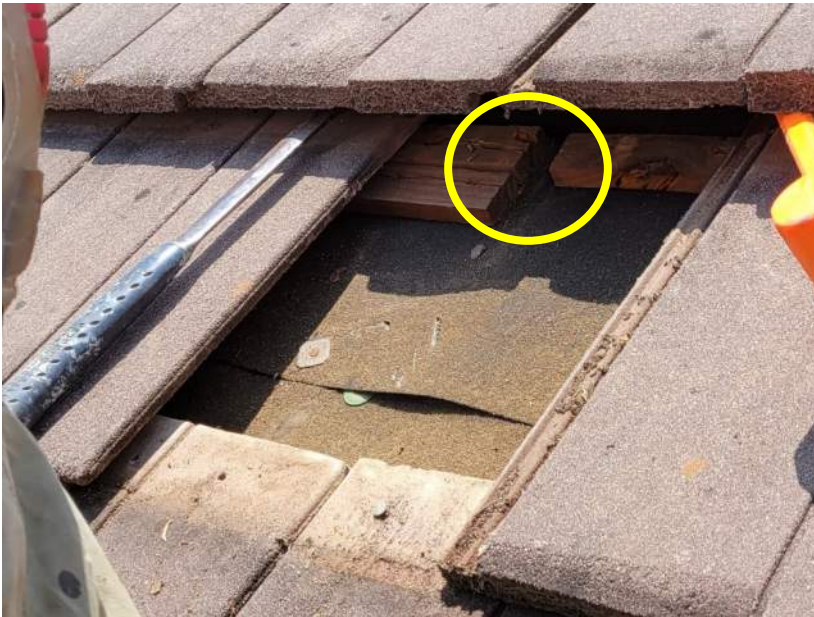
Photo 22

Auditorium Roof. Approximate 1 in. gap between wood batten sections.

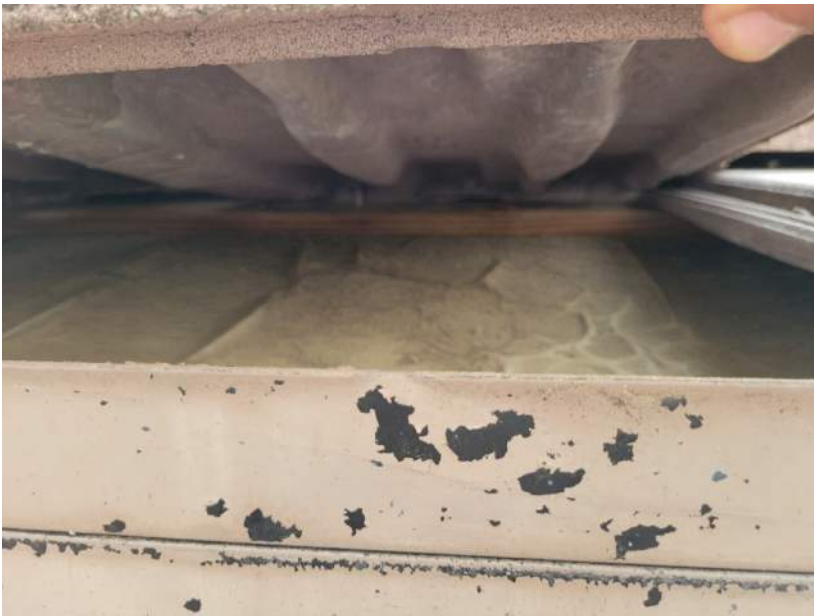
Photo 23

Tower Roof. Roofing felt at the eave.

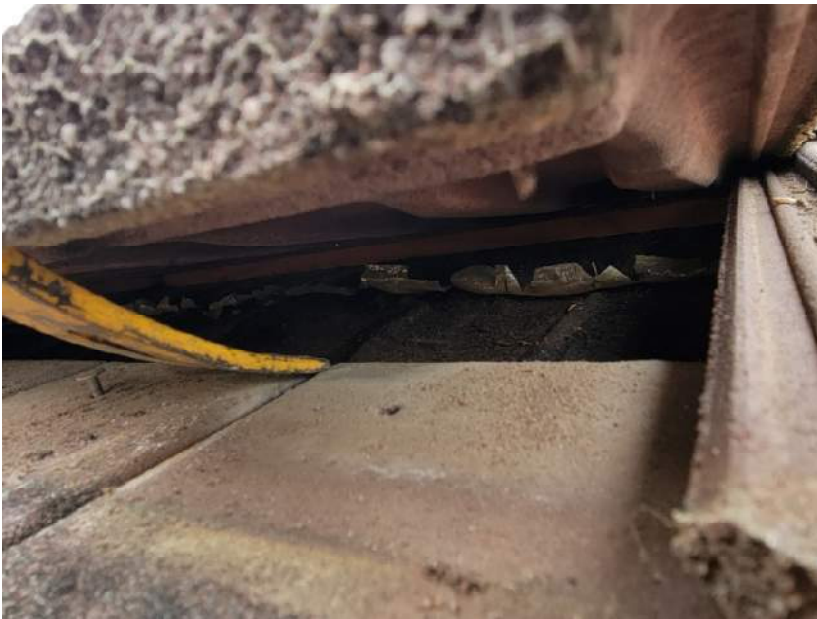
Photo 24

Main Roof. Roofing felt near the eave.

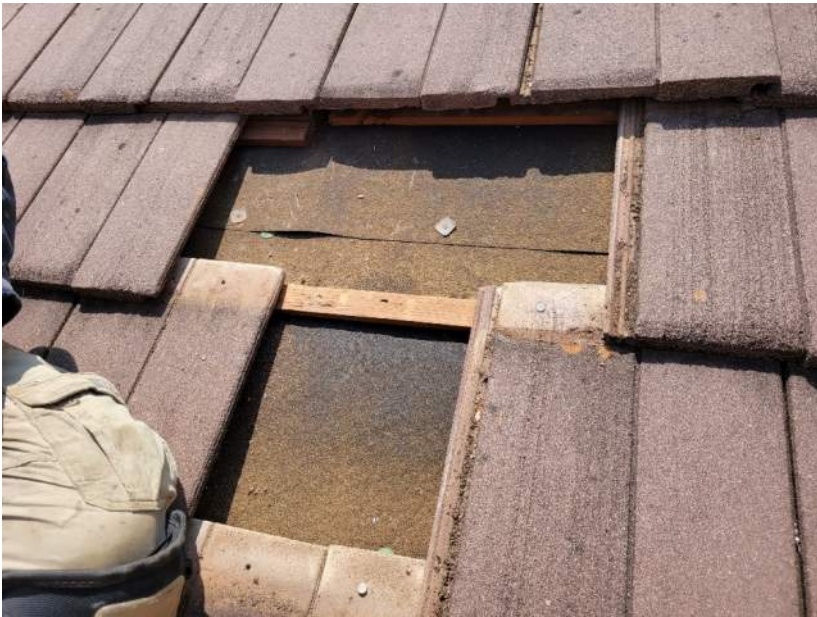
Photo 25

Auditorium Roof. Roofing felt.

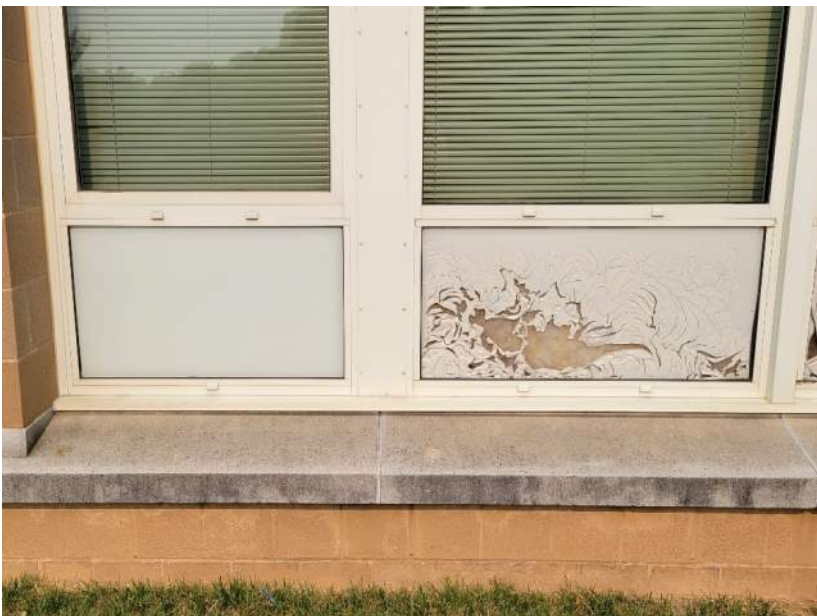
Photo 26

East Elevation. Spandrel panels; right panel has delaminated coating.

The most durable solution is to replace the monolithic back-painted glass spandrels with a product that will not show coating delamination such as ceramic fritted monolithic glazing panel or a metal panel. For improved performance, an insulated glazing unit with ceramic fritted glass could be used, but the window frame may need modifications to accommodate the increased thickness of glazing. The window system manufacturer may be able to advise on available products to fit the existing system. The perimeter will require improved detailing in the form of replacement gaskets, sealant, or both to resist water infiltration around the panels.

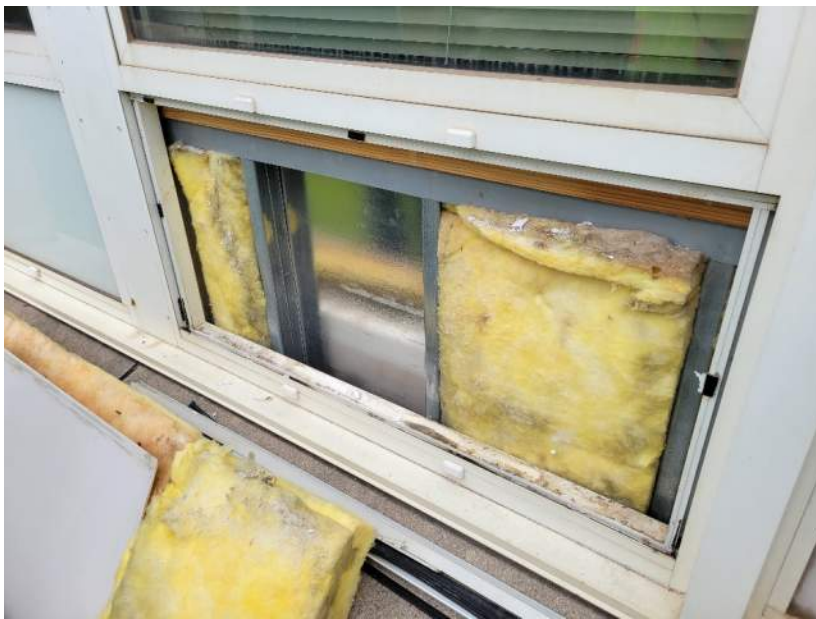
Photo 27

East Elevation. Glass Spandrel Panel Opening 1 wall cavity.

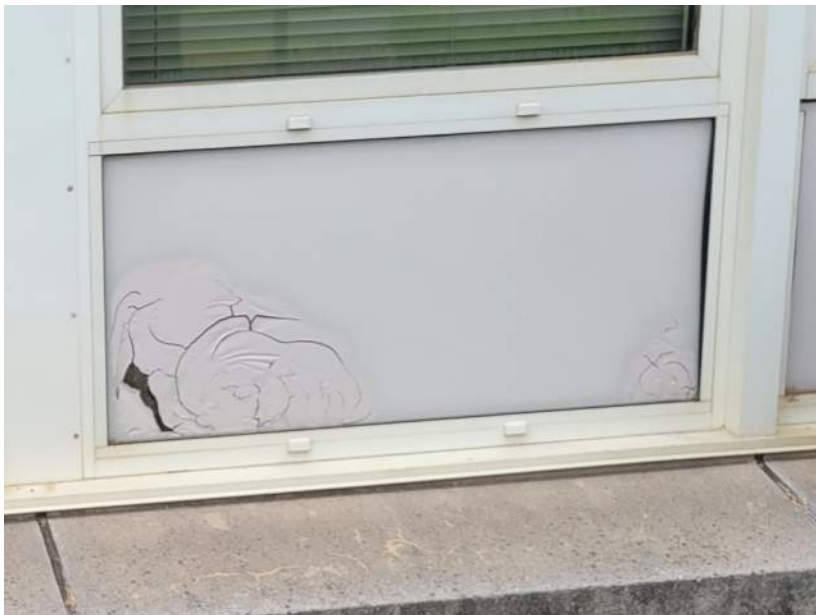
Photo 28

East Elevation. Delaminated coating of Glass Spandrel Panel Opening 1.

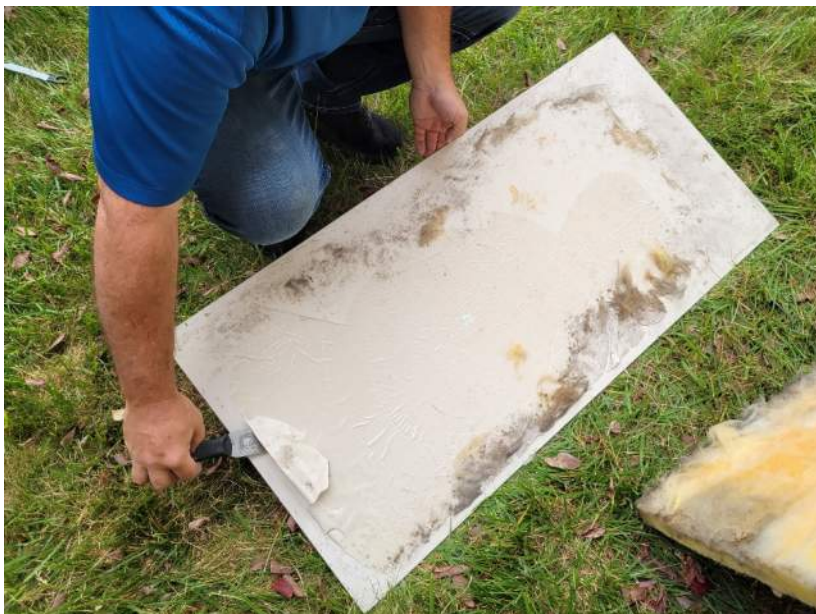
Photo 29

- Western removed two glass spandrels along the east elevation. Western easily removed the perimeter exterior gaskets and snap-in trim. Western then angled the top of the panel out and removed it from the frame. There is no sealant between these two spandrels and their respective window frames. At both openings, we observed one layer of batt insulation stuck to the back side of the panel and one layer of batt insulation in the metal stud wall cavity; the batt insulation is stained. Behind the insulation, there is a foil membrane attached to the back side of the gypsum wallboard. (Photo 27). One spandrel had cracked paint visible from the exterior (Photo 28). At the other spandrel we were unable to see the delaminated paint until the panel was removed (Photo 29).

East Elevation. Delaminated coating view on back side of Glass Spandrel Panel Opening 2.

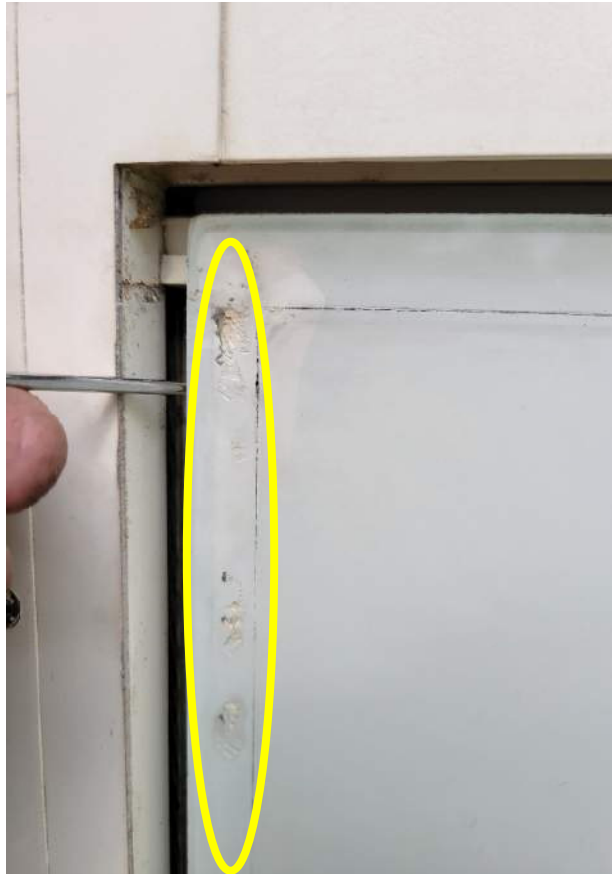
Photo 30

East Elevation. Perimeter sealant (circled) of spandrel panel that Western was unable to remove.

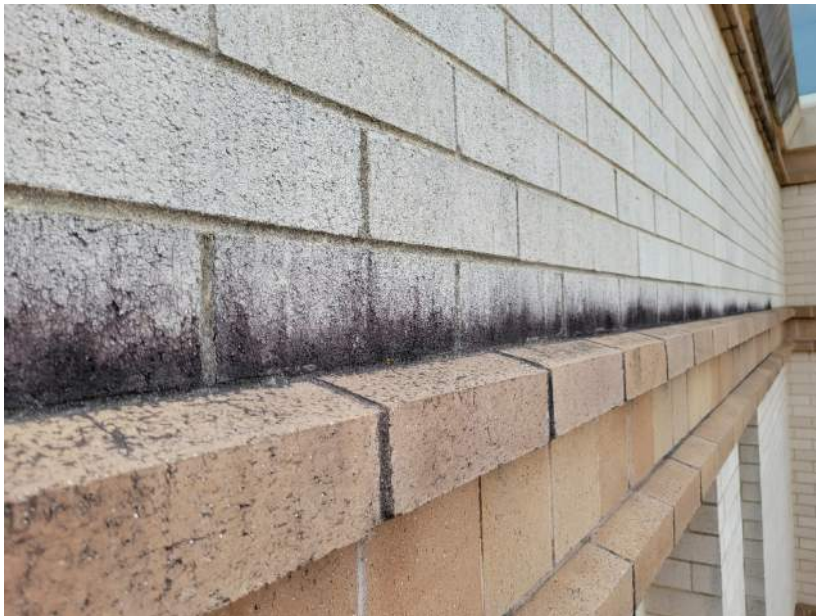
Photo 31

- Isolated locations of stained masonry and mortar joints (Photo 31).
- Isolated recessed mortar joints, in particular, above the cast stone sills at the Level 2 slab elevation (Photo 32).

East Elevation. Stained masonry and mortar joints.

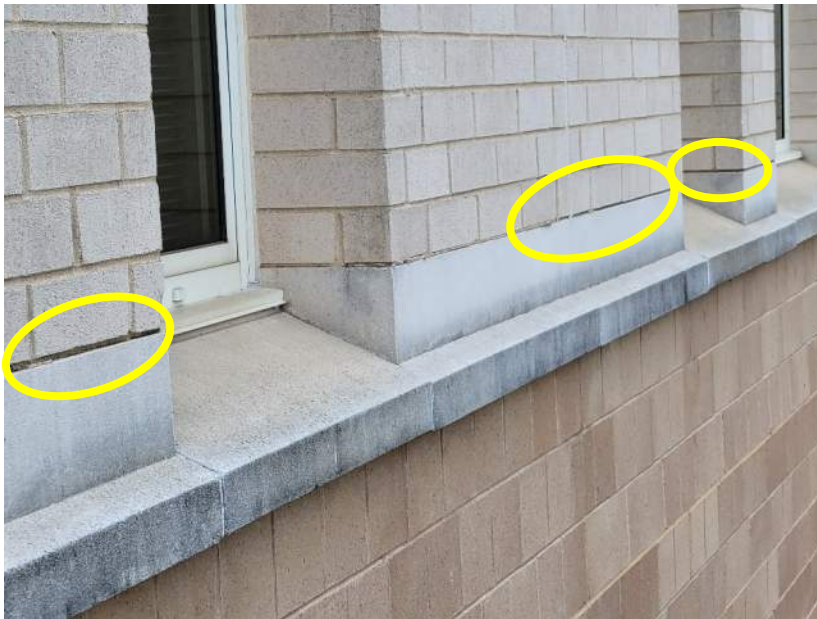
Photo 32

East Elevation. Recessed mortar joints (circled).

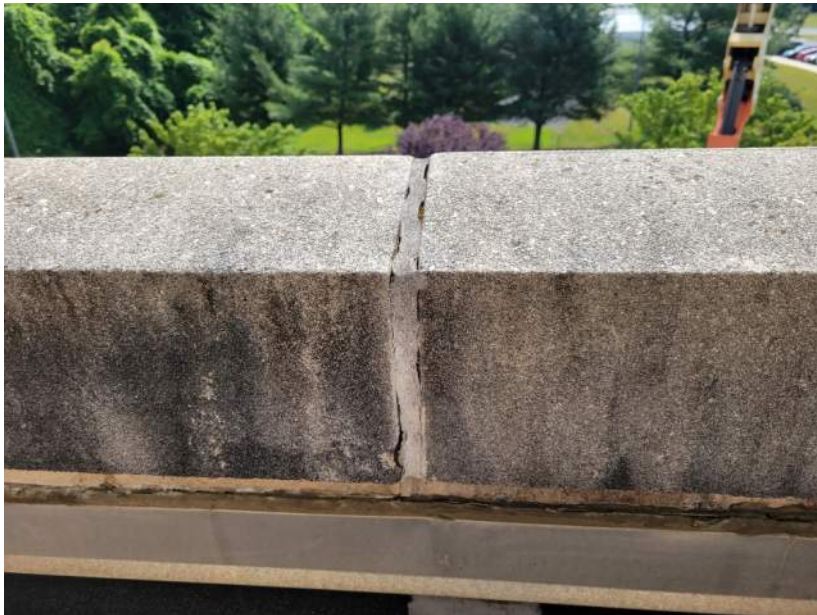
Photo 33

- Cracked sealant joints between cast stone coping blocks (Photo 33).
- Cracked sealant joints around window perimeters.
- Crack in the masonry facade on the second-floor level of the north elevation at the northeast corner of the building (Photo 34). The crack typically went through mortar joints and spanned eleven vertical courses. At the approximate midspan of the crack, the masonry appears to bow outward from the plane of the wall. This same location occurs at the horizontal control joint at the second-floor level.

Canopy Roof. Cracked sealant joint between sections of cast stone coping.

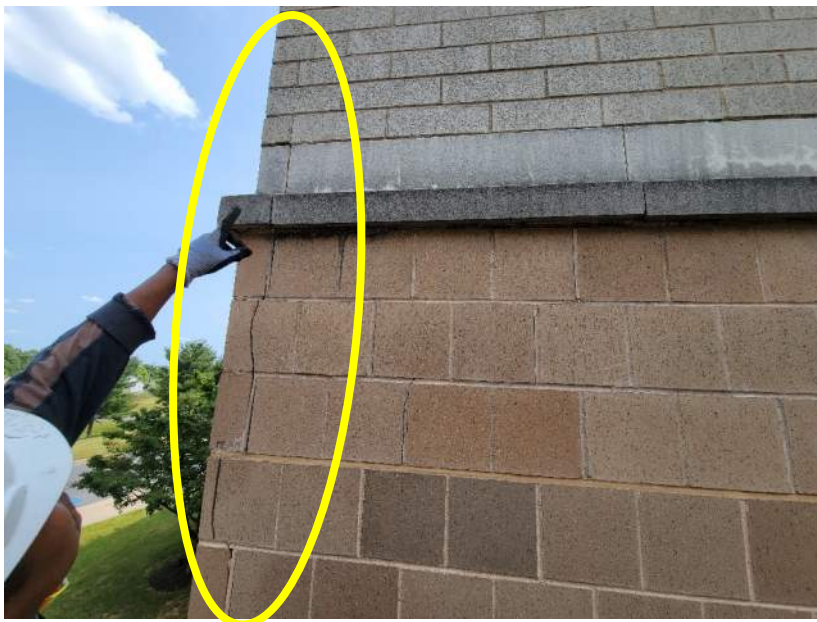
Photo 34

Second Level of North Elevation at Northeast Corner. Crack in the masonry facade.

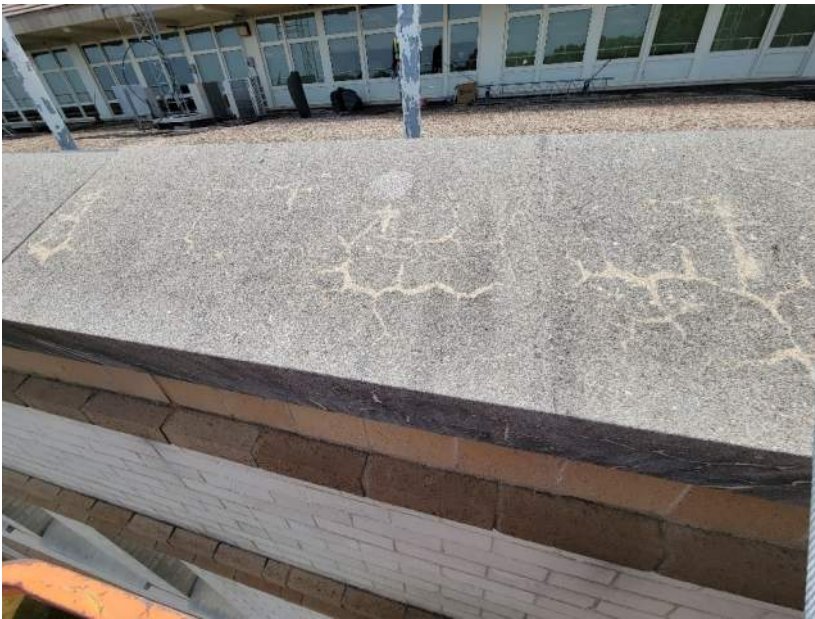
Photo 35

- Many cast stone sills and copings exhibit alligator (grid-patterned) cracking with brown staining (Photo 35). This condition is most severe at the west elevation below the location of a roof eave at the Auditorium. One sill stone has a spall, and a few others have incipient spalls.

Terrace Roof. Cast stone coping with alligator cracking and brown staining,

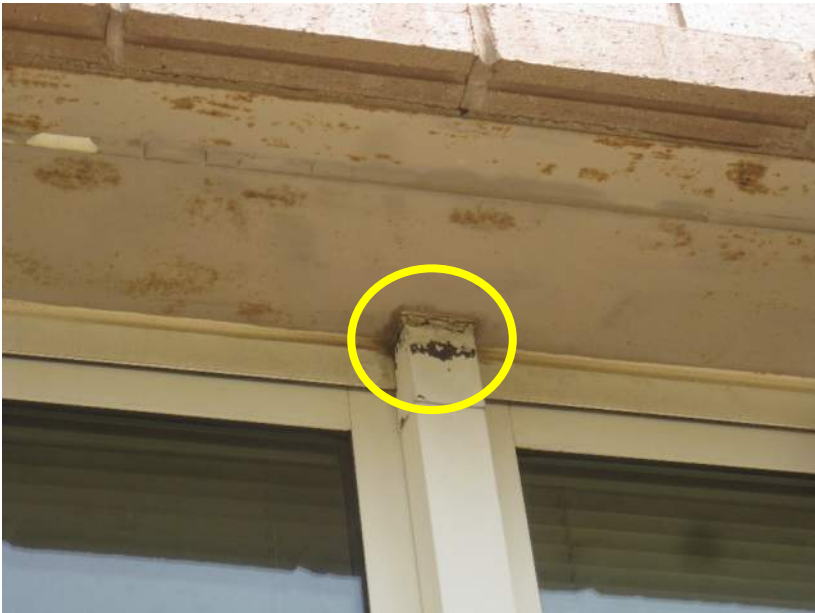
Photo 36

- Failed coating at center mullions at several windows on the west elevation (Photo 36).
- Unflushed mechanical penetrations on the west elevation (Photo 37).

West Elevation. Failed coating at center mullion.

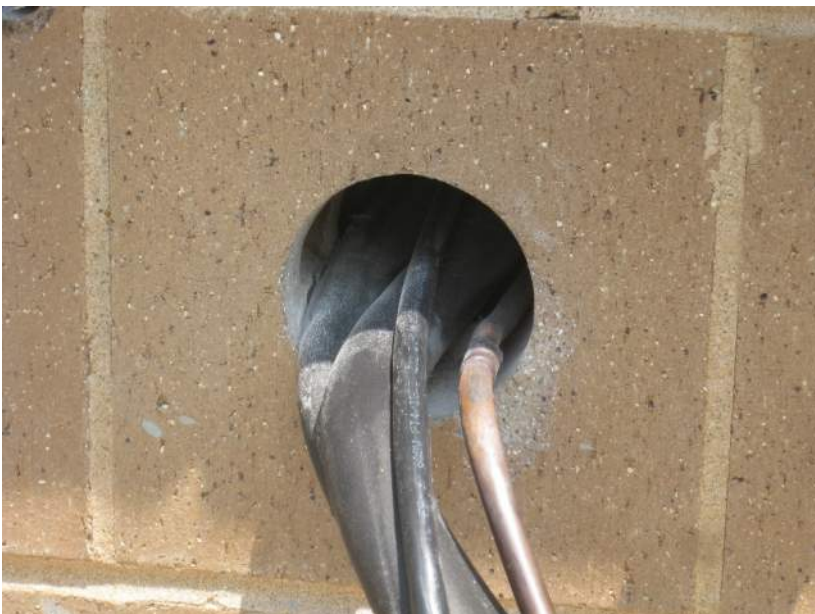
Photo 37

West Elevation. Unflashed mechanical penetration.

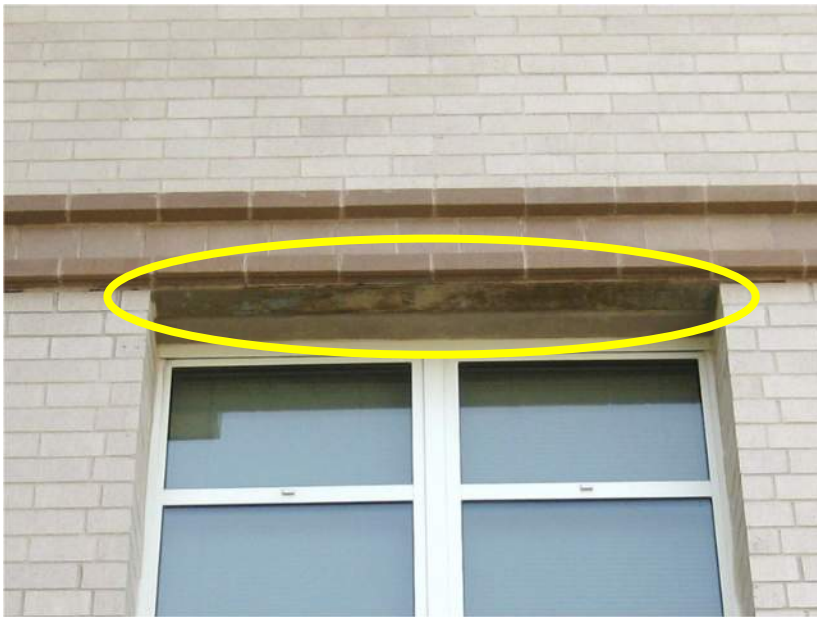
Photo 38

- Corrosion at the underside of window lintels on the north, east, and west elevations (Photo 38).
- Localized damaged below-grade waterproofing termination along the west elevation (Photo 39). The below-grade waterproofing termination in some locations stops short of the top of the concrete foundation wall (Photo 39).

North Elevation. Corrosion at the underside of window lintels (circled).

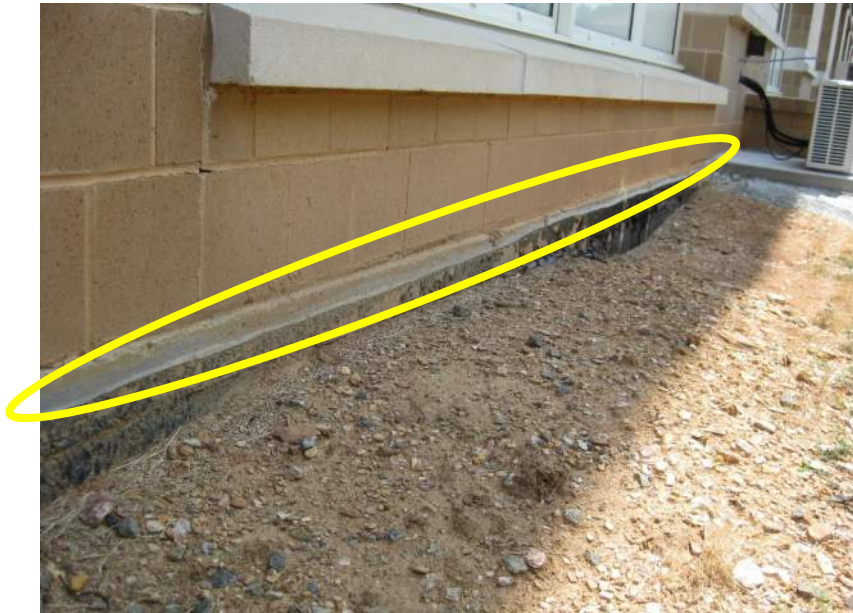
Photo 39

West Elevation. Damaged below-grade waterproofing termination and exposed concrete foundation wall (circled).

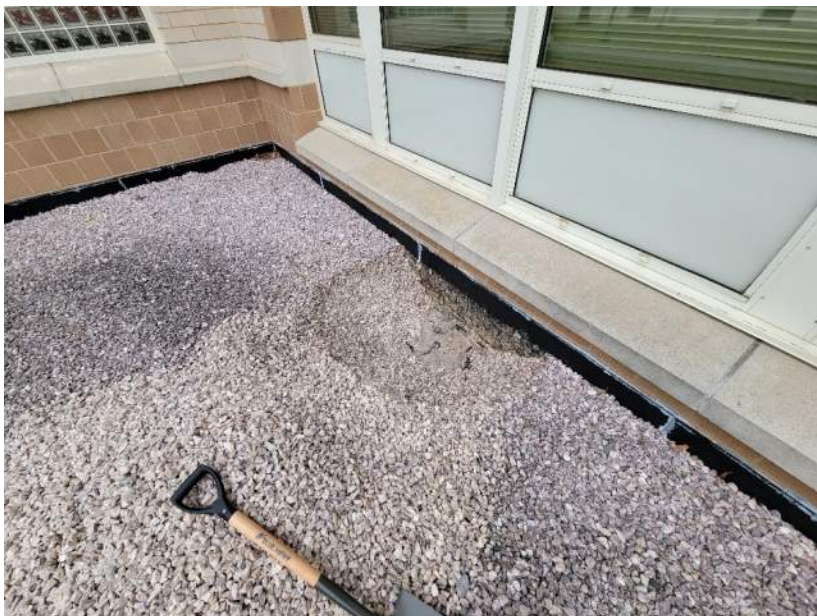
Photo 40

Central Chiller Plant Roof.
