**MONTGOMERY COLLEGE - OFFICE OF PROCUREMENT
HIGH TECHNOLOGY AND SCIENCE CENTER ROOF REPLACEMENT AND FAÇADE REPAIRS
GERMANTOWN CAMPUS**

ADDENDUM #3

High Technology & Science Center, Building Enclosure Water Infiltration Investigation, July 27, 2023.

Project 230706 – Montgomery College High Technology & Science Center, Building Enclosure Water Infiltration Investigation, 20200 Observation Drive, Germantown, MD (MC Project #FP23-037, High Technology & Science Center (HT) Roof Replacement)

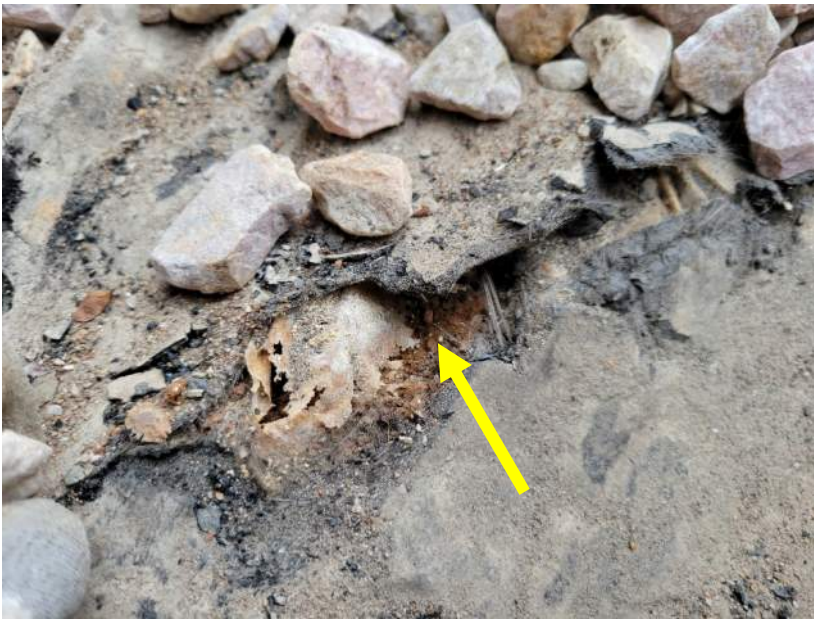
Photo 41

- The roof area is covered with gravel. After Western excavated approximately 1 ft of gravel, we observed punctures in a protection board, tears in a filter fabric, and brown earth fill material underneath (Photo 41).
- A self-adhered membrane turns up onto the face of the masonry wall. The membrane has fishmouths along the top termination (Photo 42). The membrane termination is sealed to the surface of the masonry, although most of the sealant has failed.

Central Chiller Plant Roof.
Puncture in protection board
with brown earth fill (arrow)
underneath.

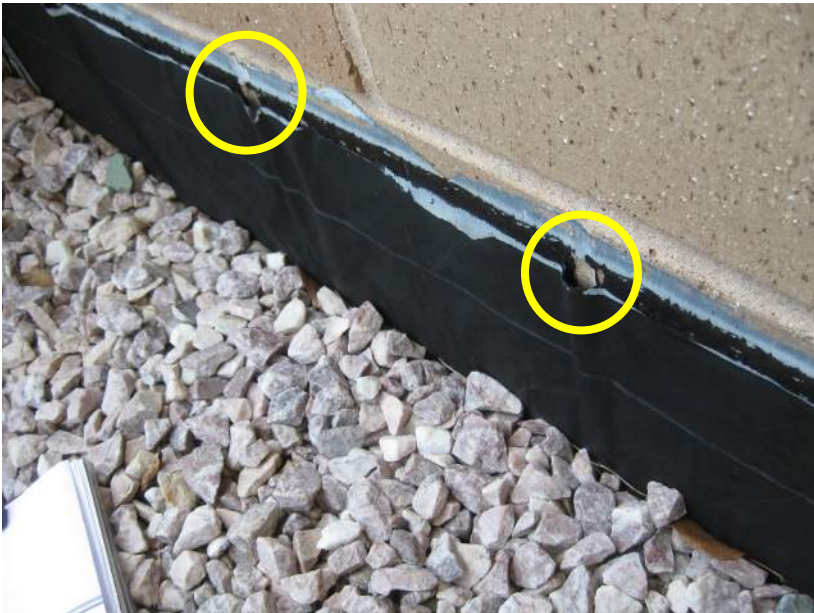
Photo 42

Central Chiller Plant Roof.
Fishmouths (circled) in the
membrane along the top
termination against the
building masonry veneer.

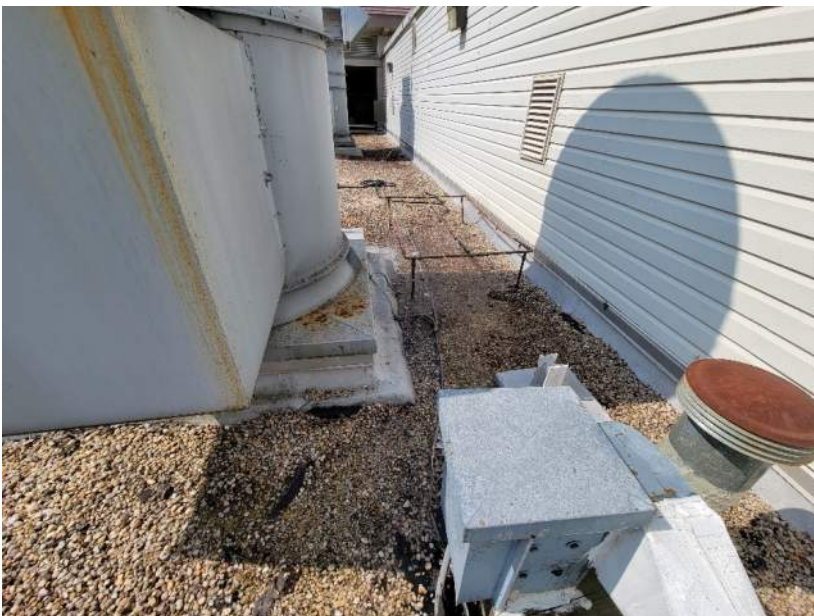
Photo 43

Test	Test Area	Duration	Test Equipment	Results
WT1	Low-slope roof between emergency vent fire hood penetration and rising wall (Photo 43)	30 mins.	Spray Rack	No observed water intrusion

Main Roof. Water Test WT1.

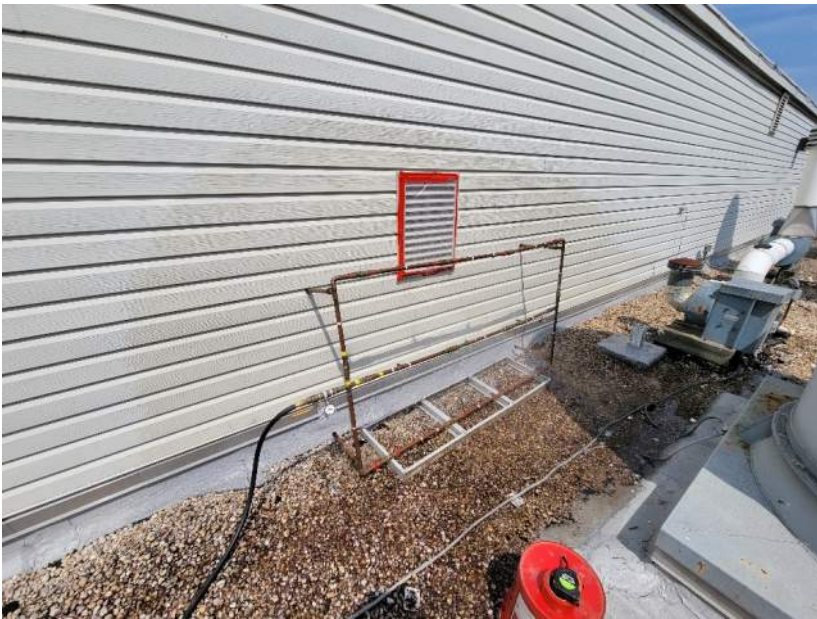
Photo 44

Test	Test Area	Duration	Test Equipment	Results
WT2	Low-slope-to-rising wall transition near WT1 (Photo 44)	16 mins.	Spray Rack	Approximately 15 mins into testing, we observed water intrusion at the chemical hood duct penetration in Classroom 405. We stopped the testing shortly after first observing the leakage due to the significant volume of water entering the interior.
WT3	Same location as WT1 (Photo 45)	30 mins.	Spray Rack	No observed water intrusion
WT4	Metal coping joint cover plate at rising wall above WT1 through WT3 (Photo 46)	30 mins.	Nozzle	We observed similar water intrusion as seen in WT2 but observed that the chemical hood duct penetration was unintentionally being sprayed. We adjust the nozzle to eliminate the penetration from being sprayed and the water intrusion stopped shortly thereafter. We observed no other water intrusion at the fourth floor or within the crawlspace.

Main Roof. Water Test WT2.

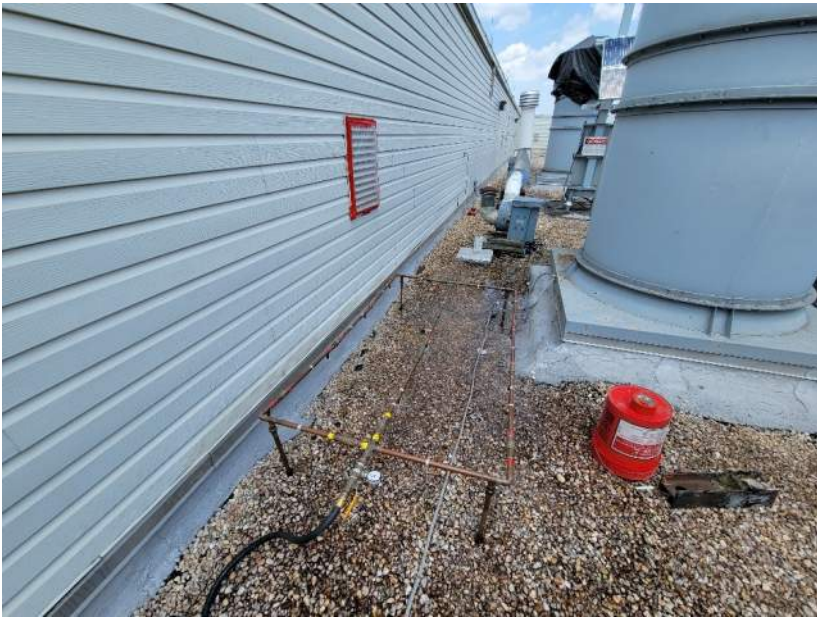
Photo 45

Main Roof. Water Test WT3.

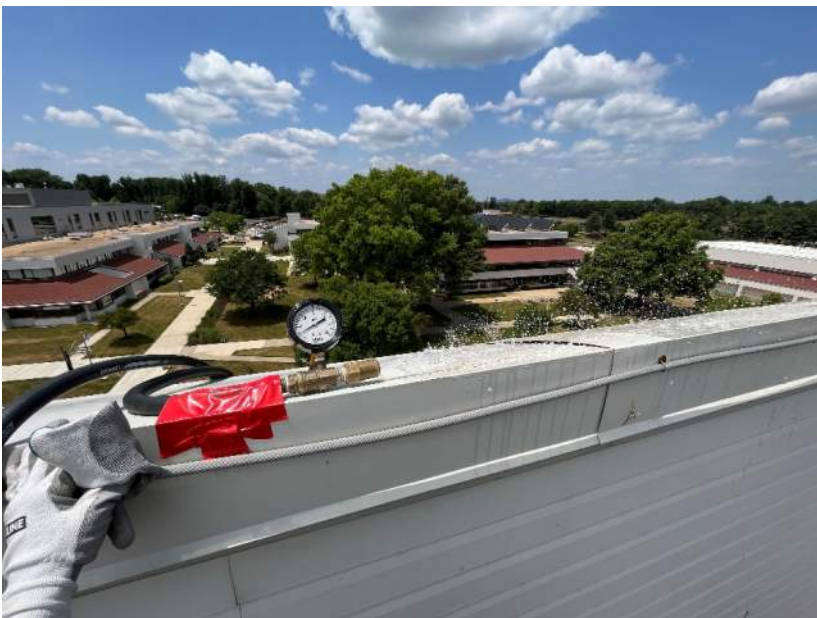
Photo 46

Main Roof. Water Test WT4.
