**OFFICE OF PROCUREMENT
CONSTRUCTION MANAGER AT RISK FOR THE MACKLIN TOWER (MT) LIBRARY RENOVATION, ROCKVILLE CAMPUS
RFP NO.: 625-004
RFP CLOSING DATE AND TIME: SEPTEMBER 24, 2024 @ 2:00 PM**

**ADDENDUM #1
ISSUED: SEPTEMBER 6, 2024**

Section 5 of Appendix C: Asbestos-Containing Materials Survey for the Gordon & Marilyn Macklin Tower (Library), Rockville Campus, Final Report dated July 2, 2021

ASBESTOS-CONTAINING MATERIALS SURVEY

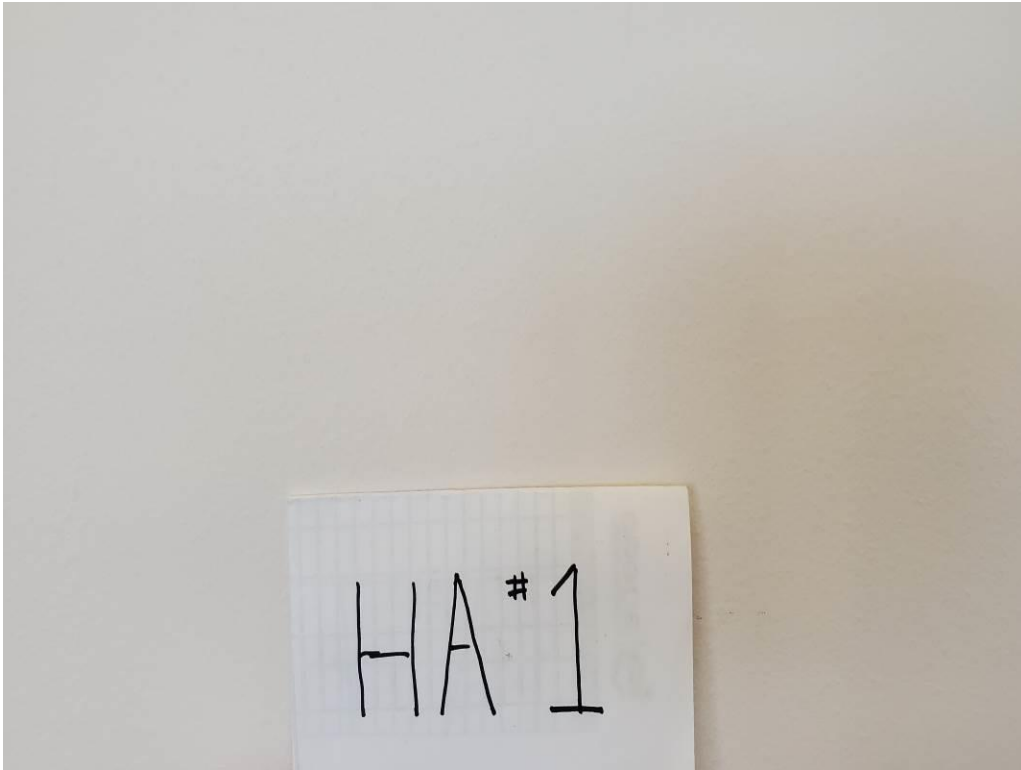
HA #1 – Gypsum Board Sheeting

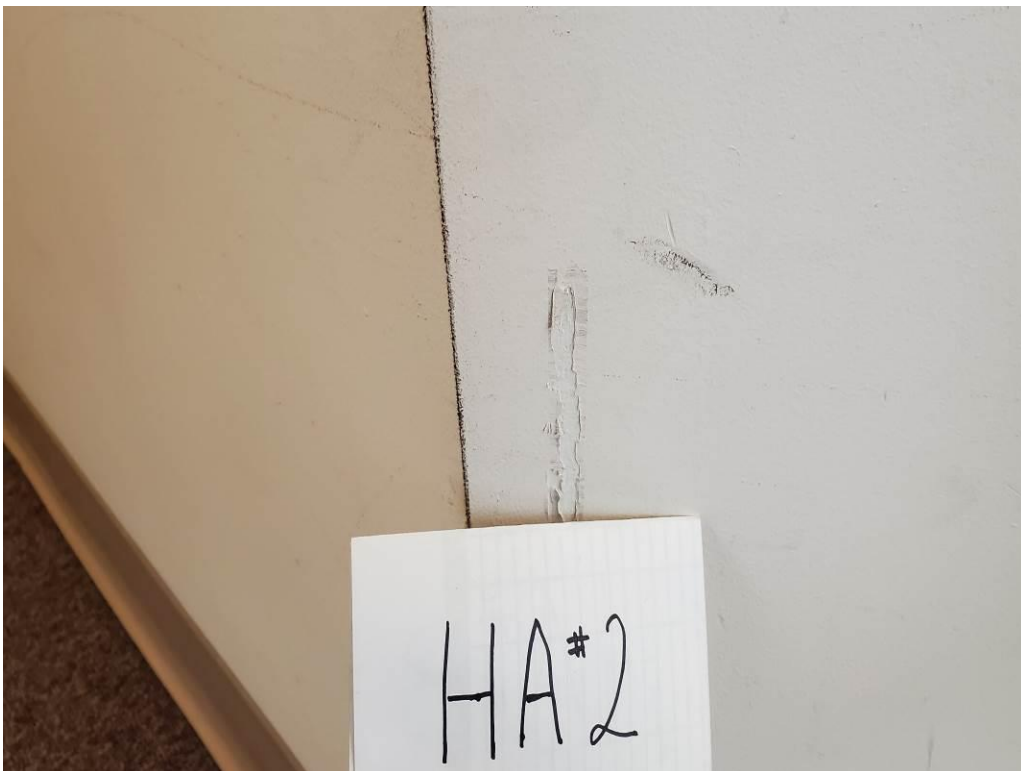
HA #2 – Joint Finishing Compound

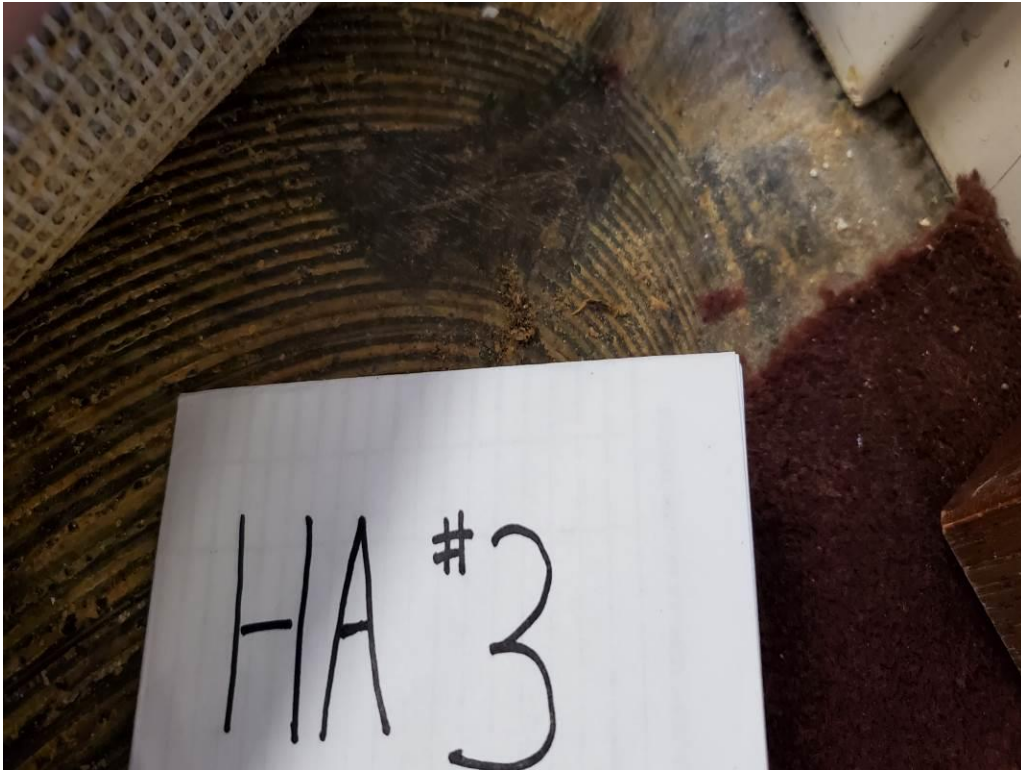
HA #3 – Black Floor Tile Mastic

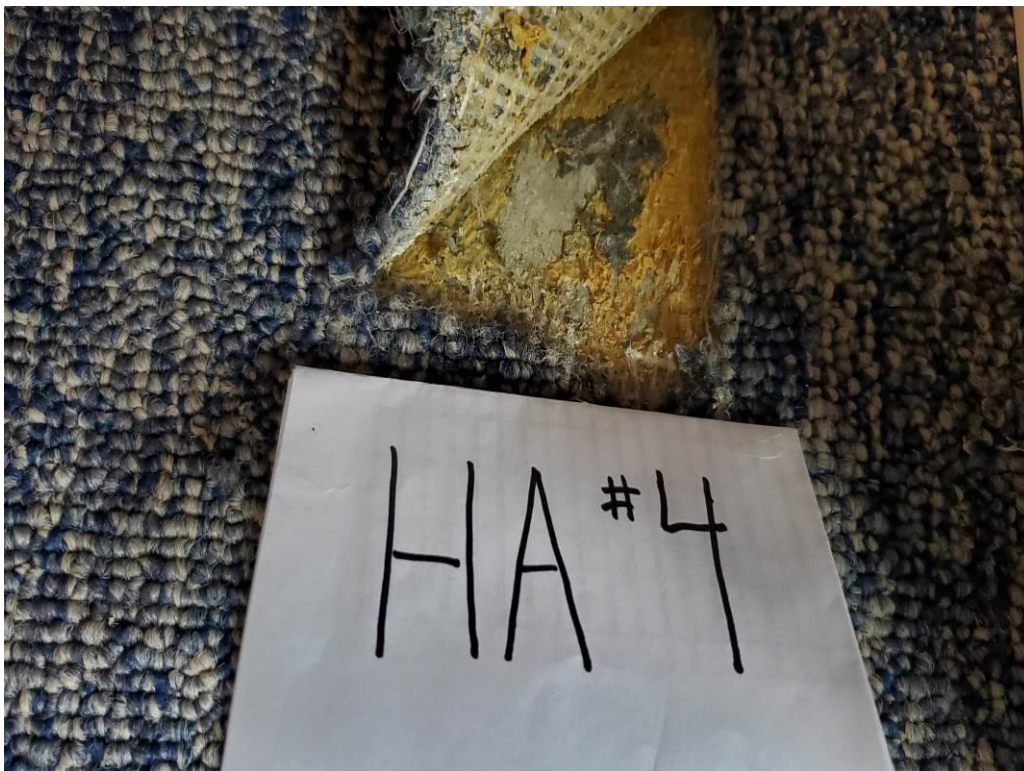
HA #4 – Yellow Carpet Mastic

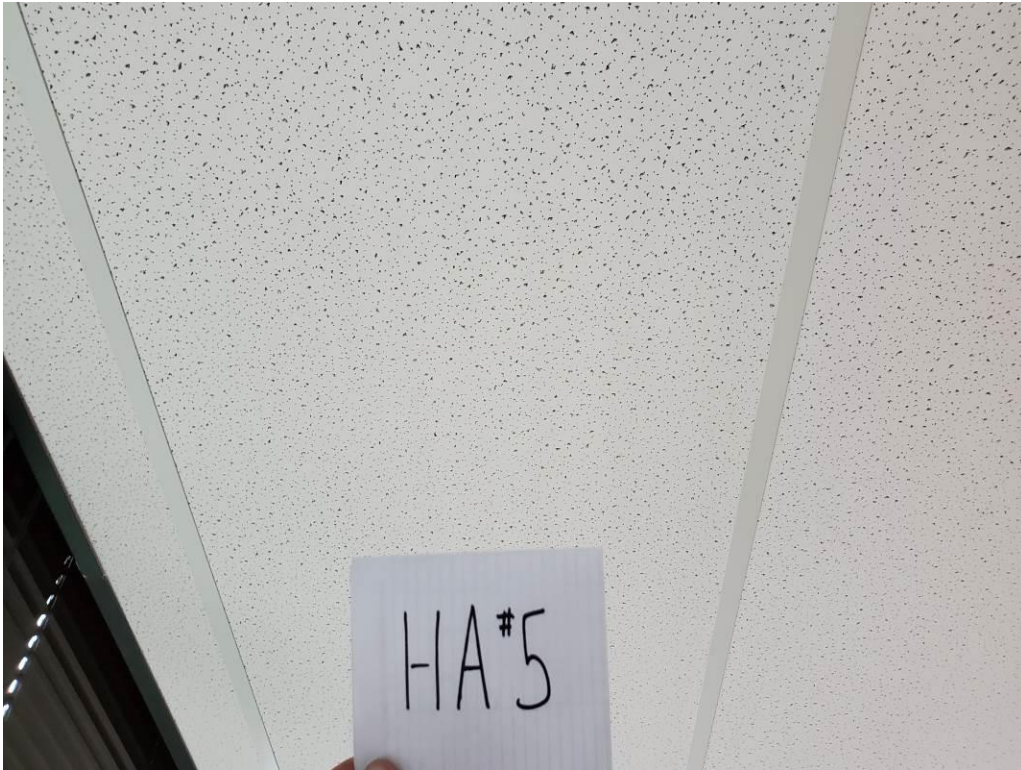
HA #5 – 2'x4' White Pinhole & Puncture ACT

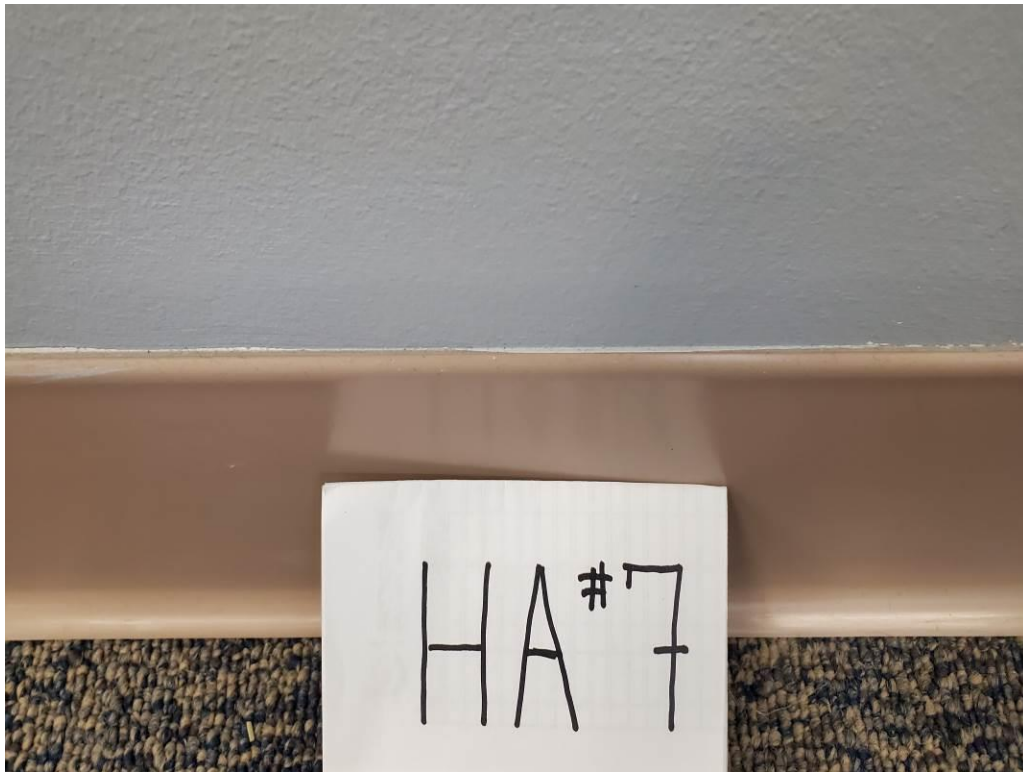
HA #7 – Tan Vinyl Cove Base w/ Mastic

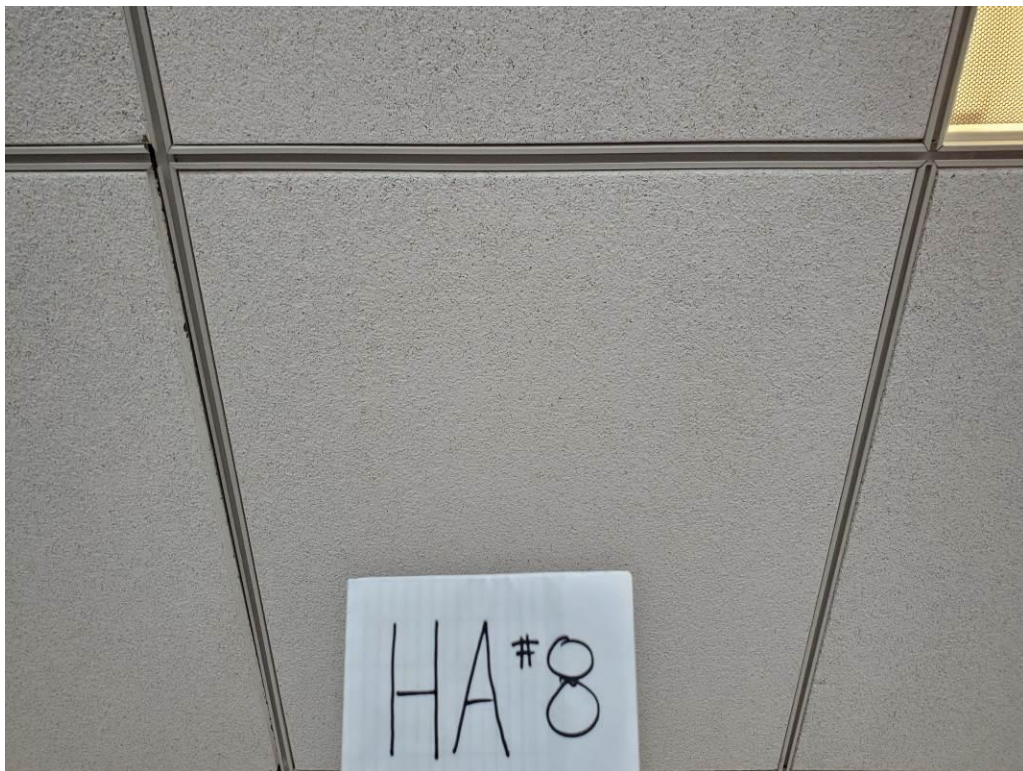
HA #8 – 2'x2' White Textured ACT

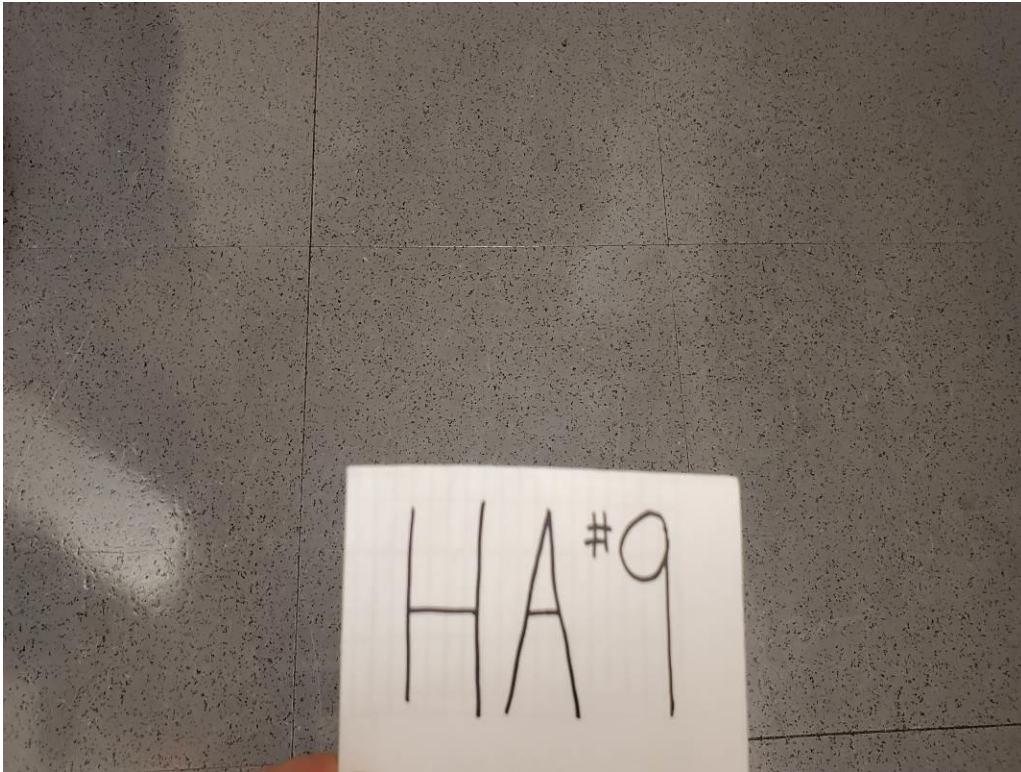
HA #9 – 12”x12” Dark Blue w/ Black Spots VFT & Mastic

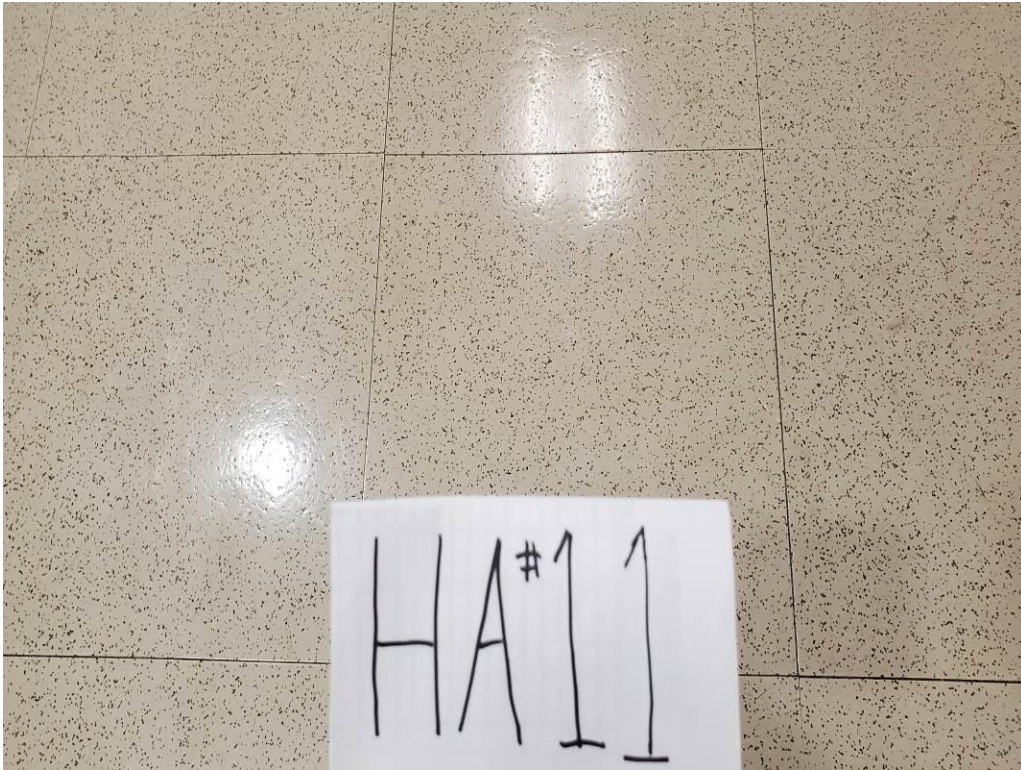
HA #11 – 12”x12” Brown w/ Black Spots VFT & Mastic

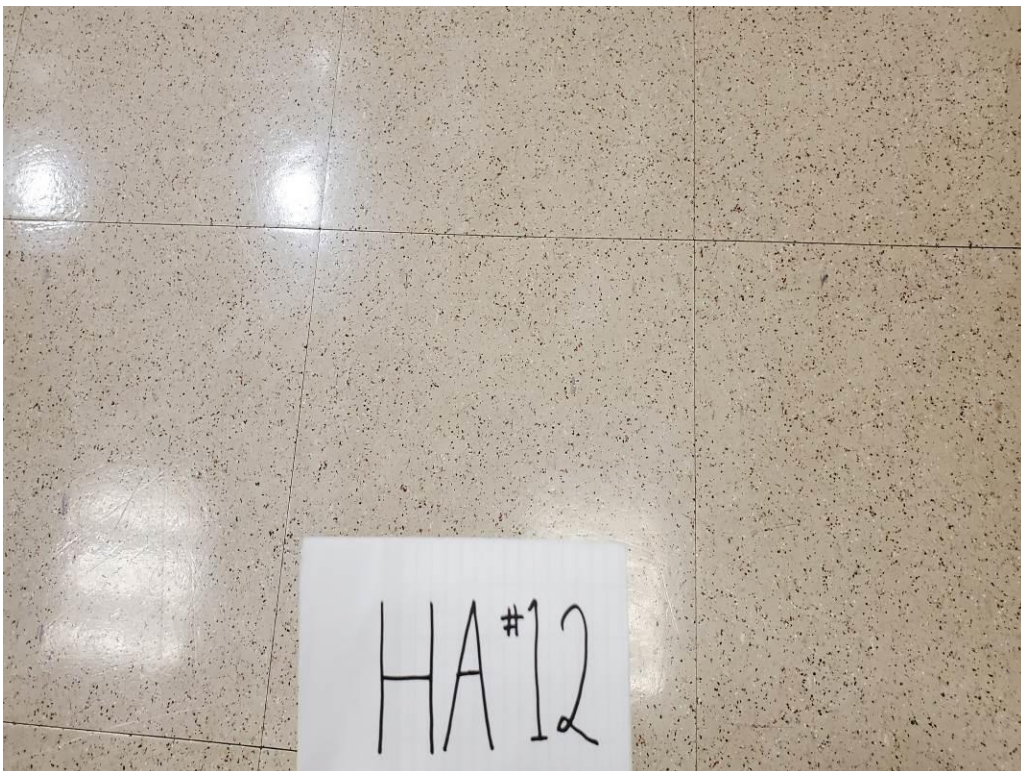
HA #12 – 12”x12” Pink w/ Multicolored Spots VFT & Mastic

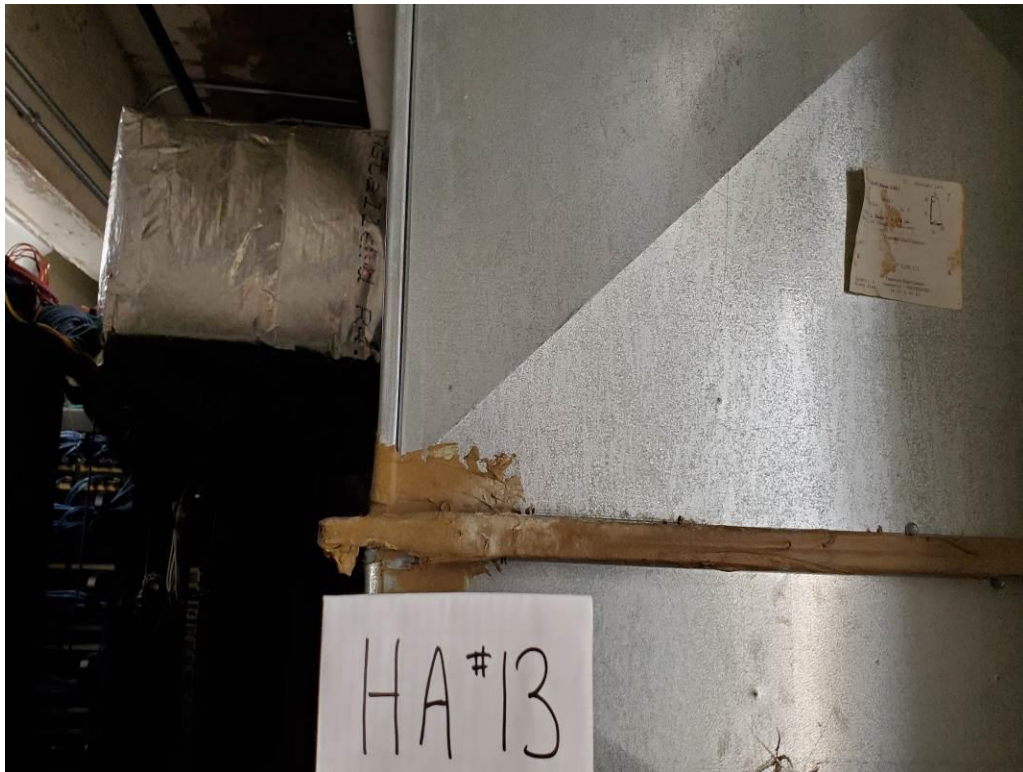
HA #13 – Brown Metal Duct Seam Sealant

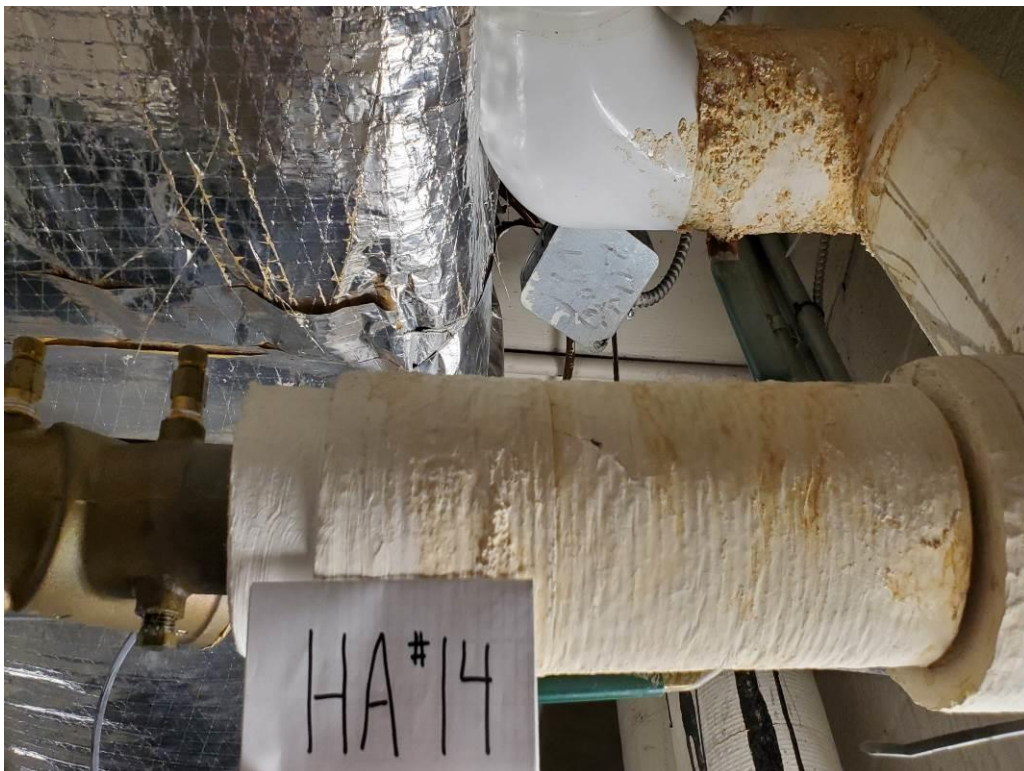
HA #14 – White Pipe Insulation Mastic

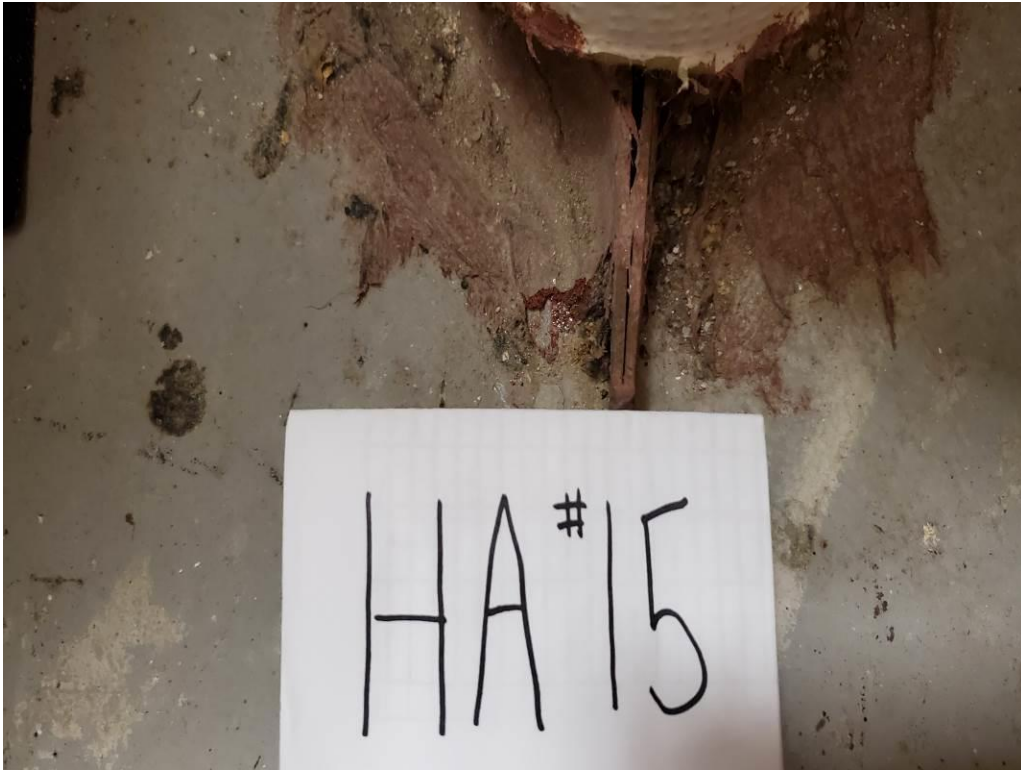
HA #15 – Red Fire Stop

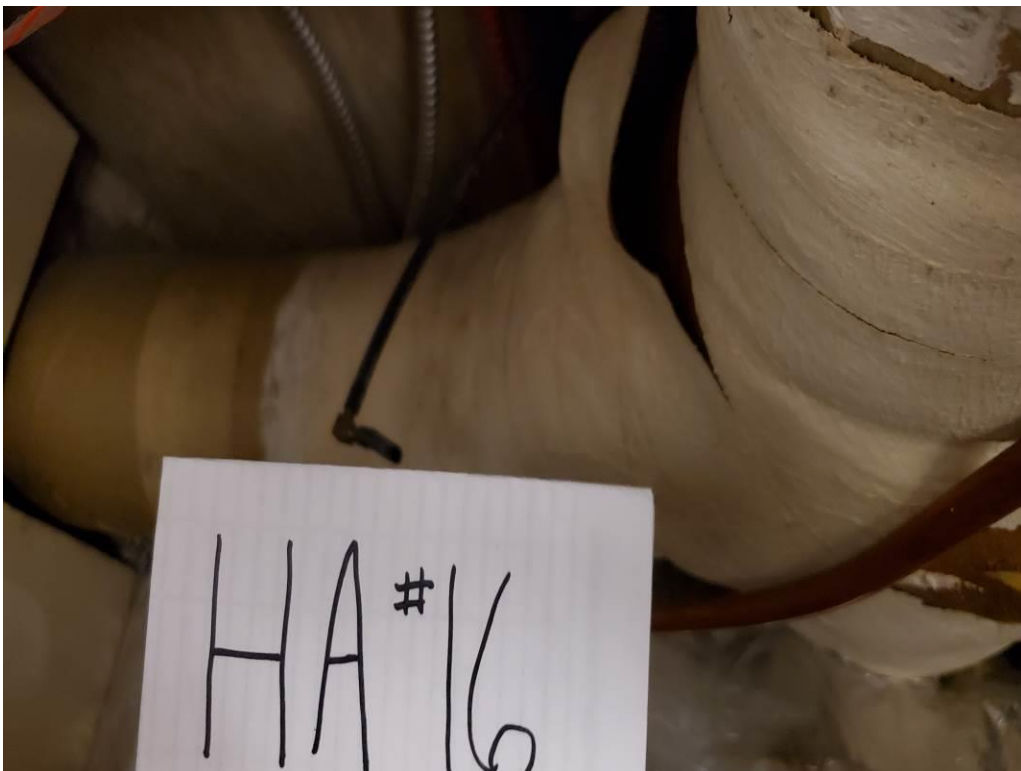
HA #16 – Off-White Pipe Wrap Mastic

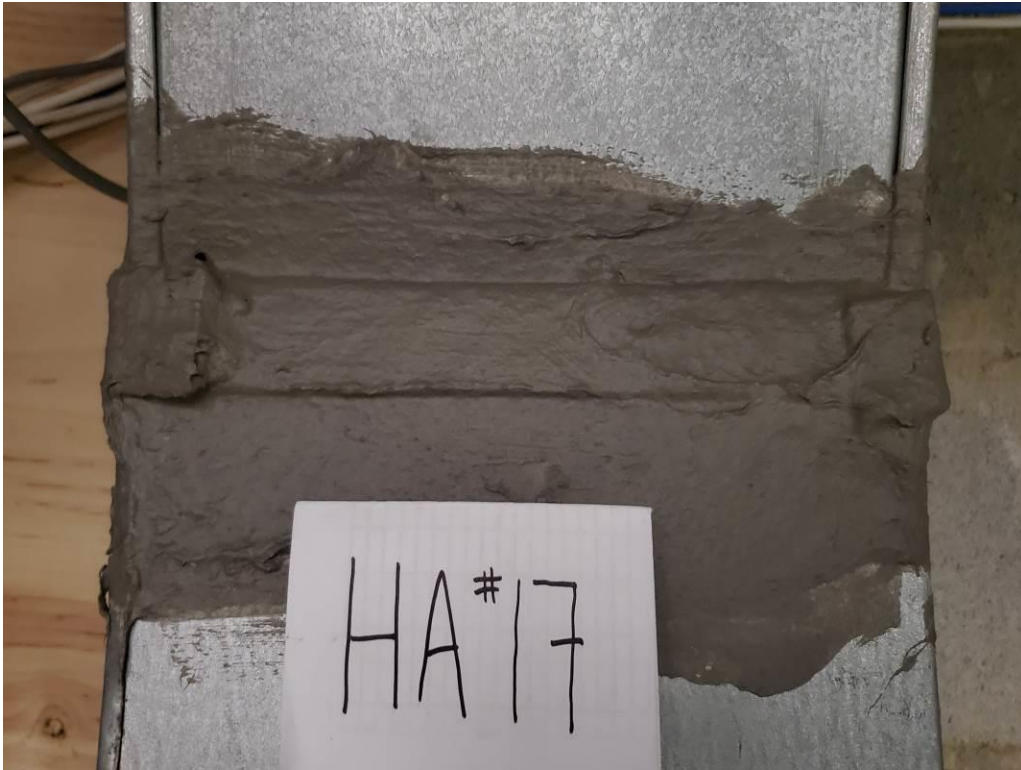
HA #17 – Gray Metal Duct Seam Sealant

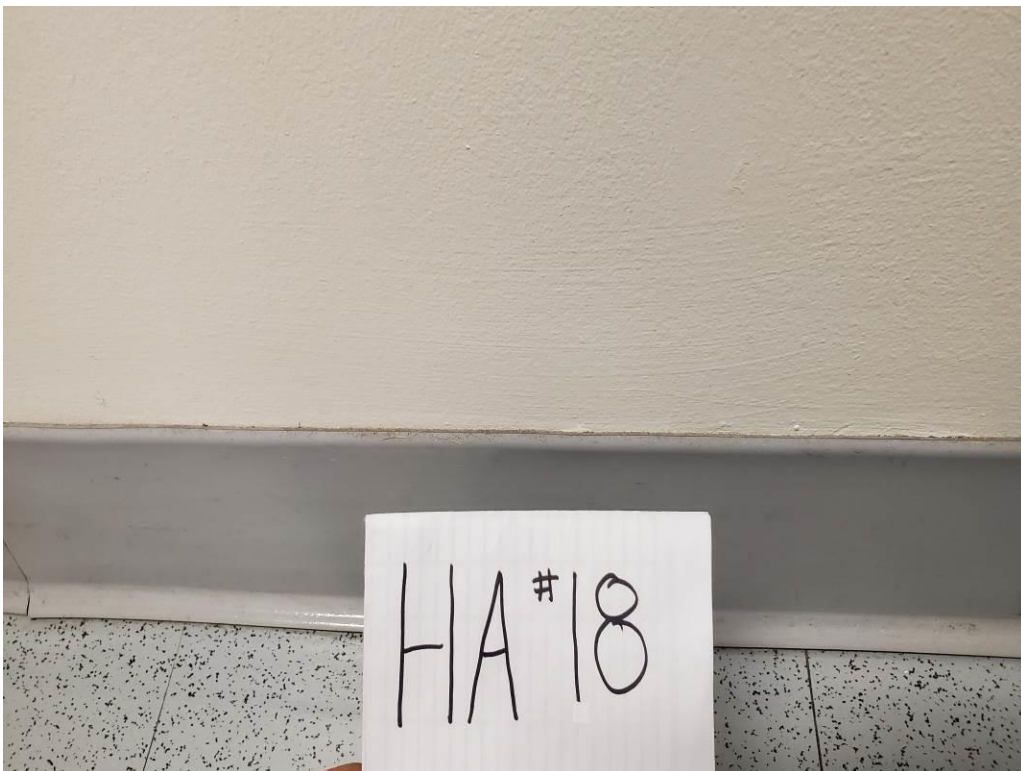
HA #18 – Gray Vinyl Cove Base w/ Mastic

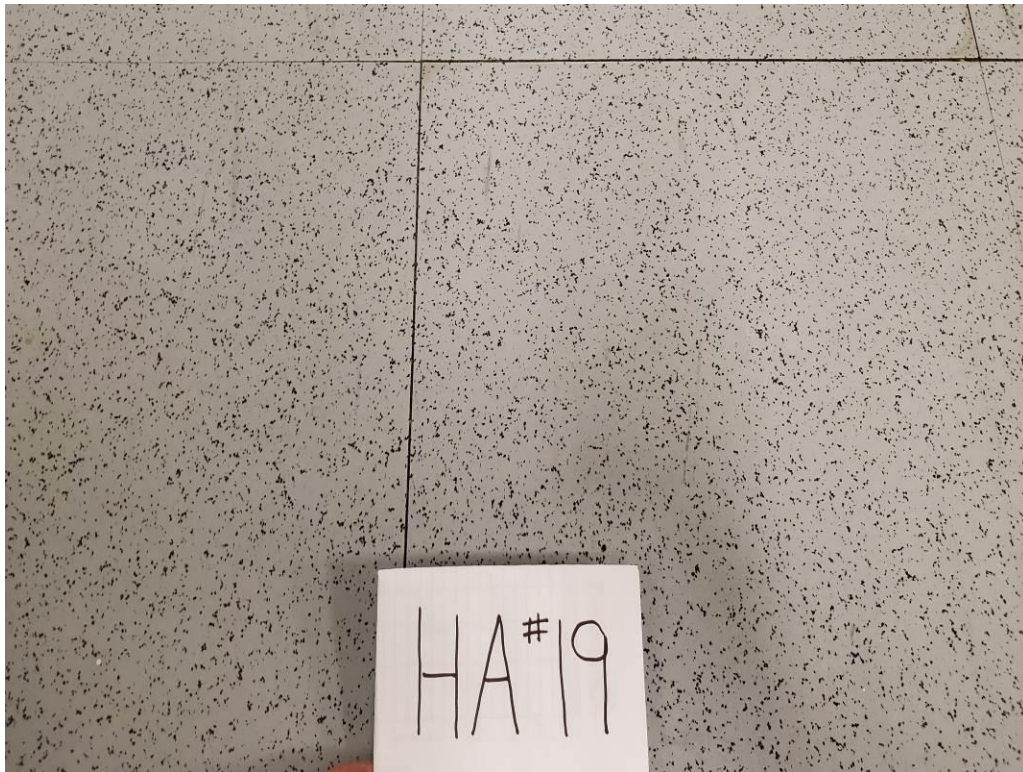
HA #19 – 12”x12” Light Blue w/ Black Spots VFT & Mastic

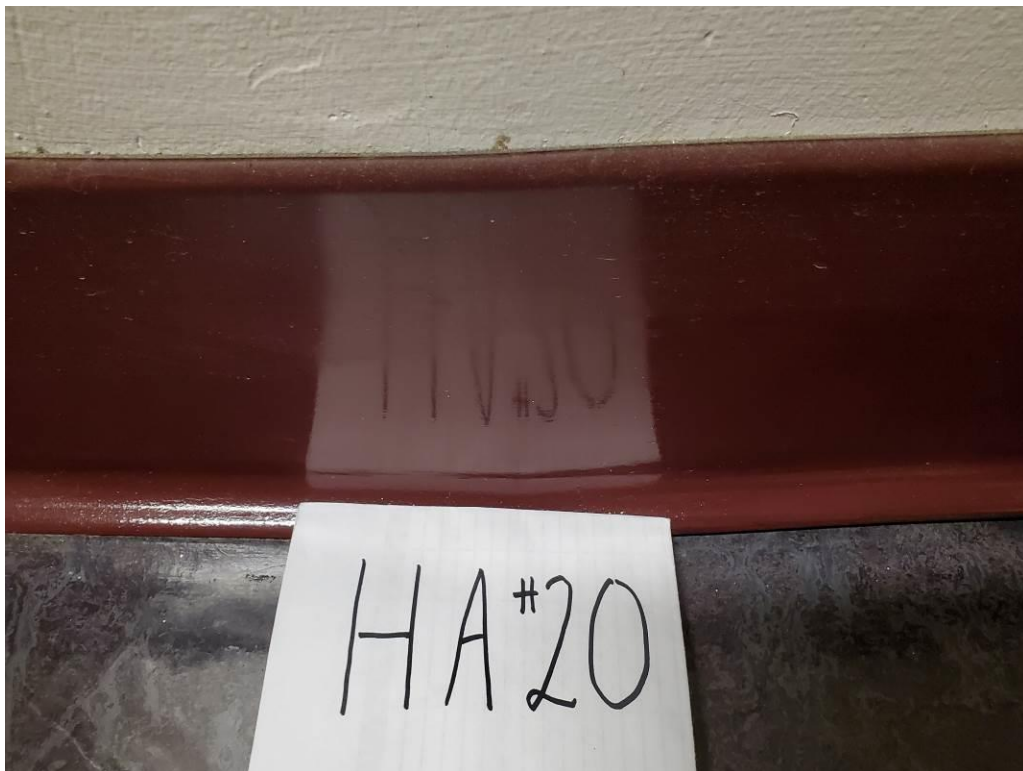
HA #20 – Maroon Vinyl Cove Base w/ Mastic

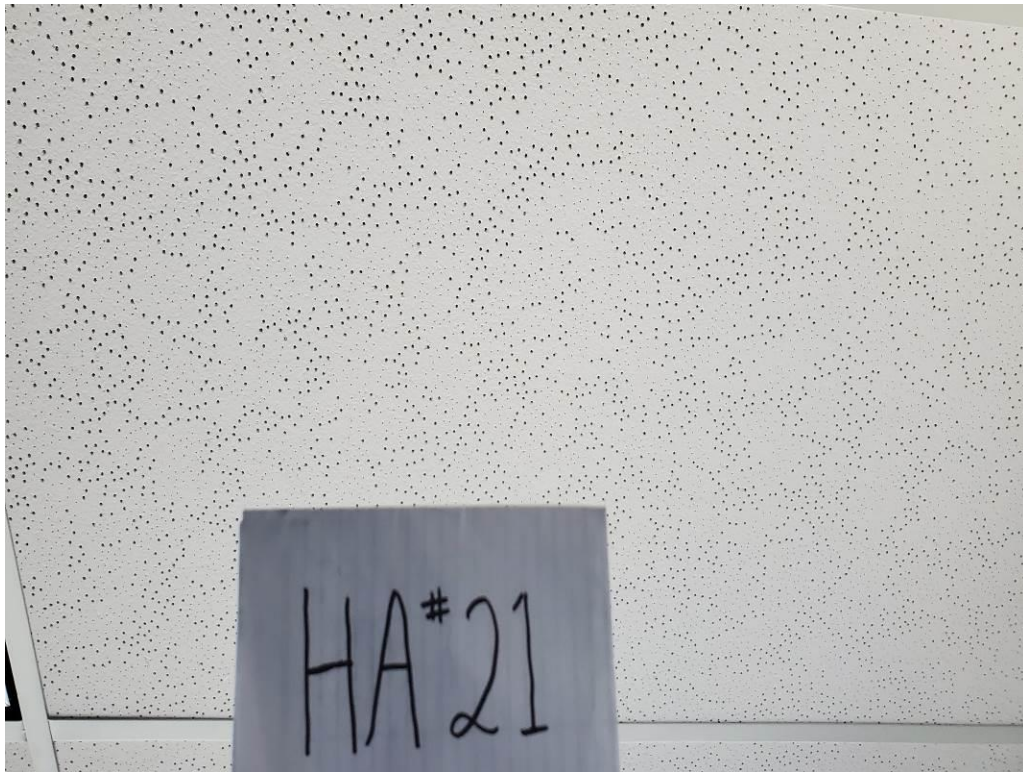
HA #21 – 2’x4’ White Small & Large Pinhole ACT

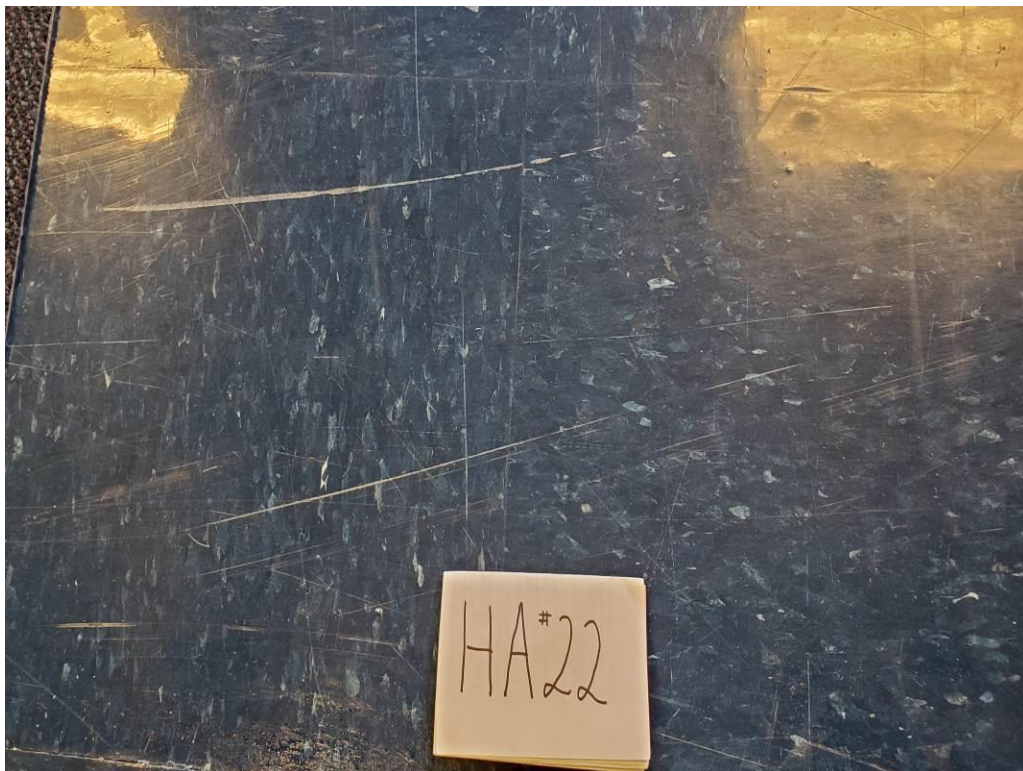
HA #22 – 12”x12” Navy Blue w/ Light Blue Specks VFT & Mastic

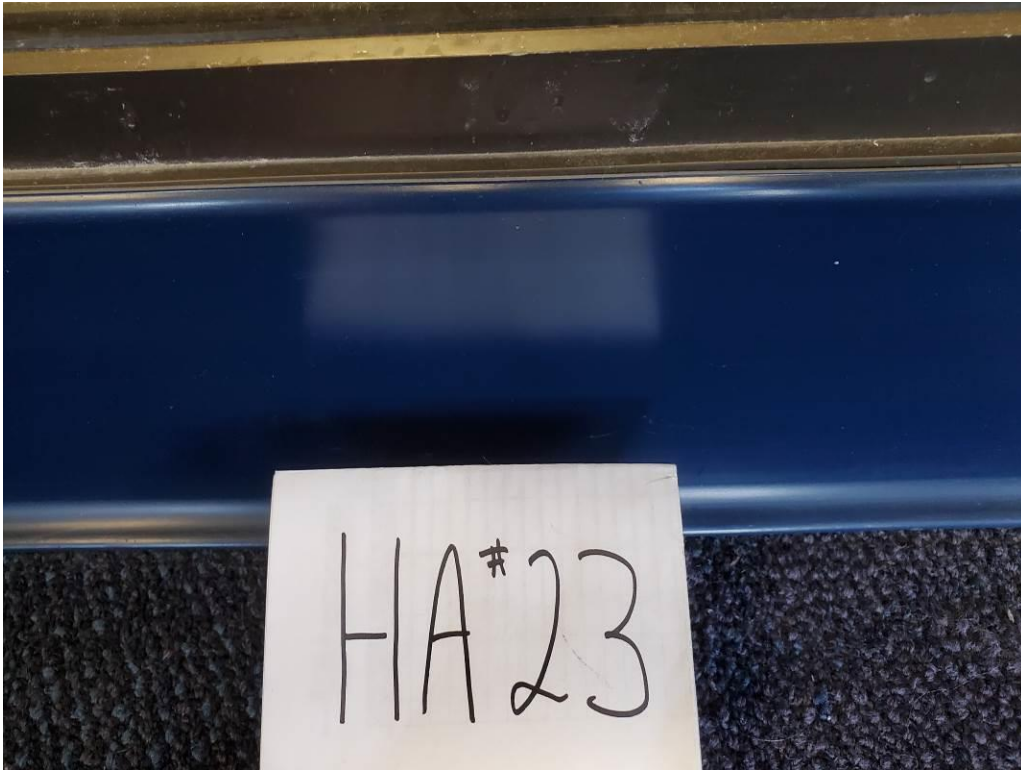
HA #23 – Navy Blue Vinyl Cove Base w/ Mastic

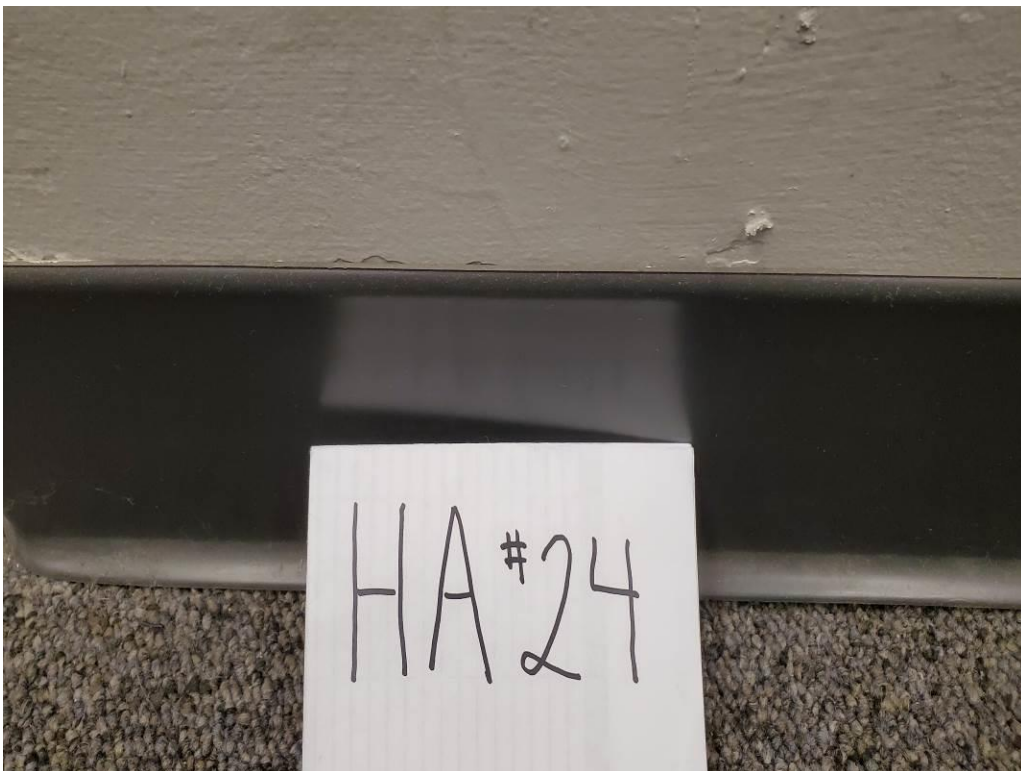
HA #24 – Black Vinyl Cove Base w/ Mastic

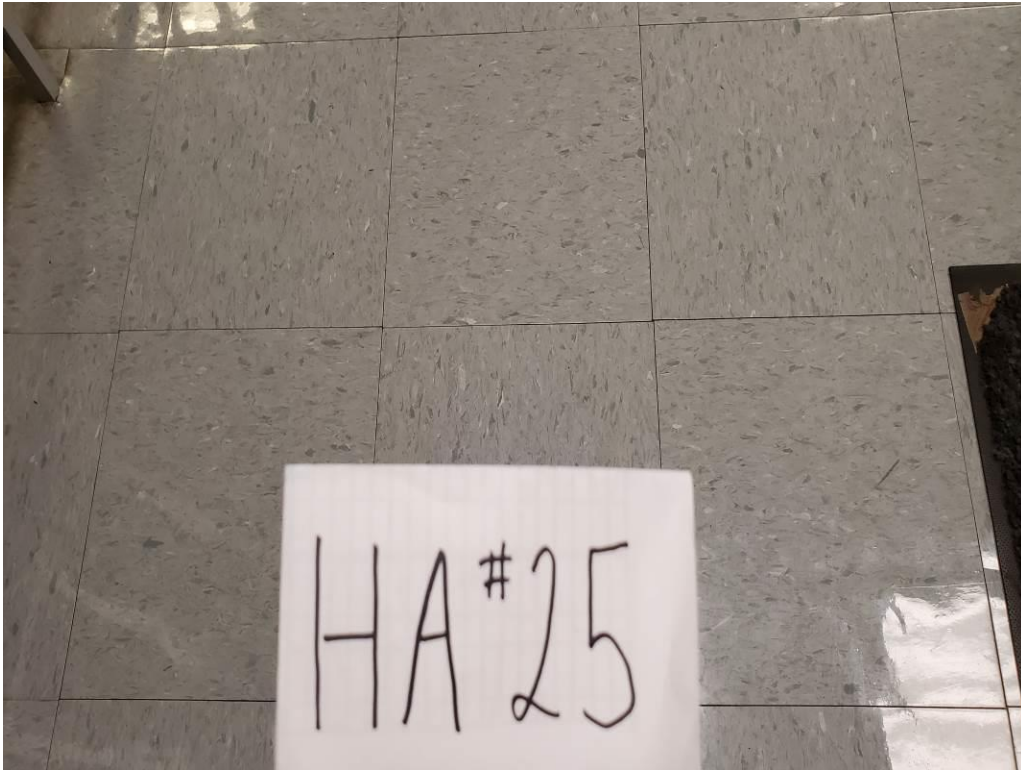
HA #25 – 12”x12” Light Blue w/ Blue Specks VFT & Mastic

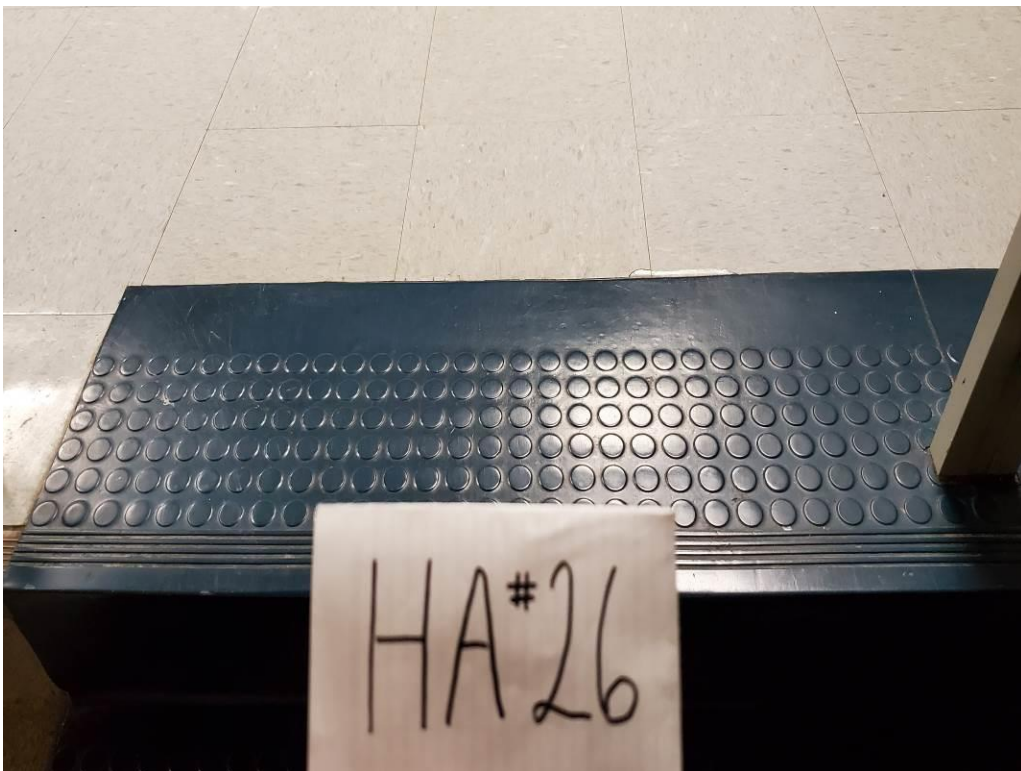
HA #26 – Navy Blue Vinyl Stair Tread w/ Mastic

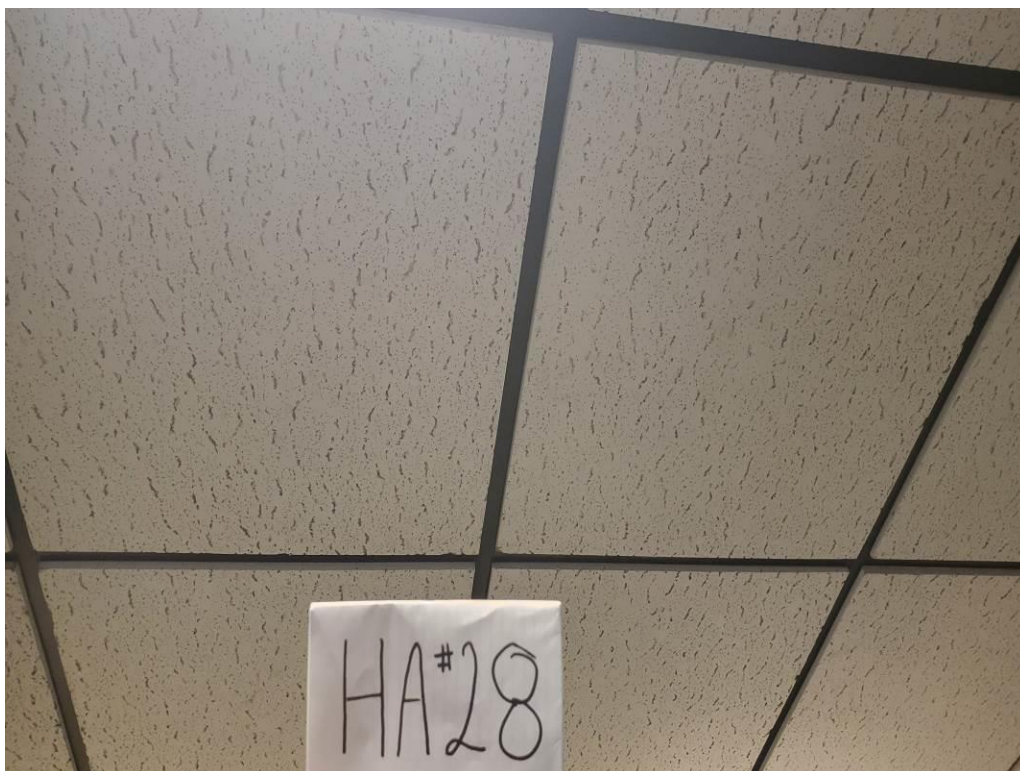
HA #28 – 2'x2' Off-White Inset Pinhole & Fissure ACT

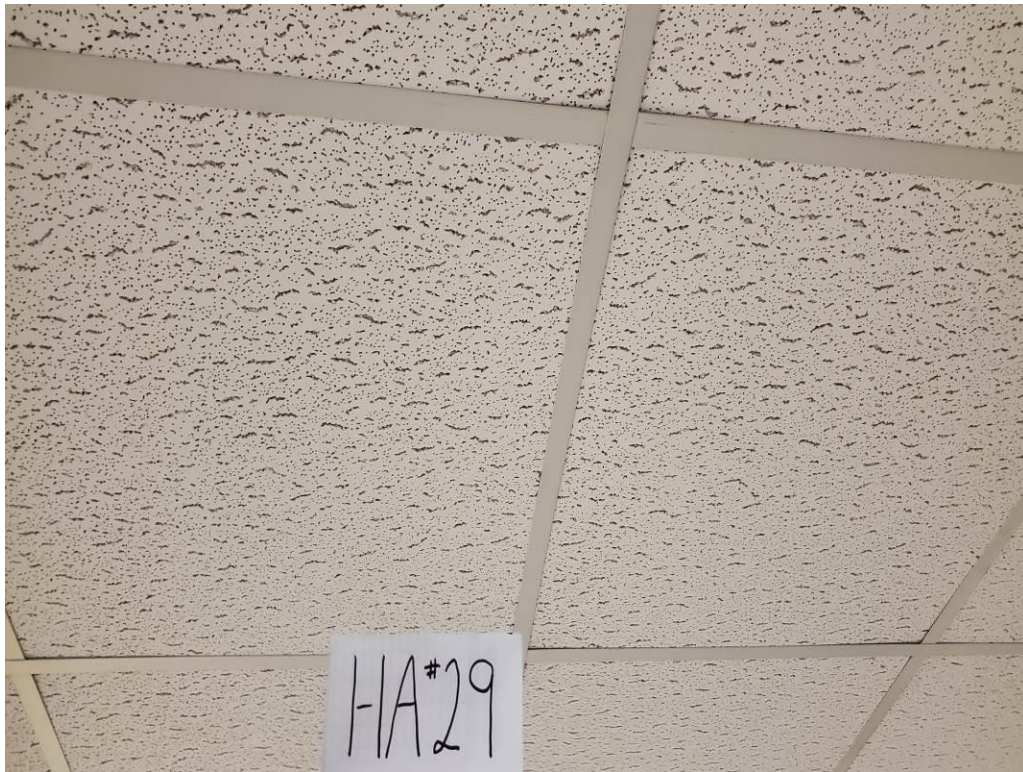
HA #29 – 2'x2' White Pinhole & Fissure ACT

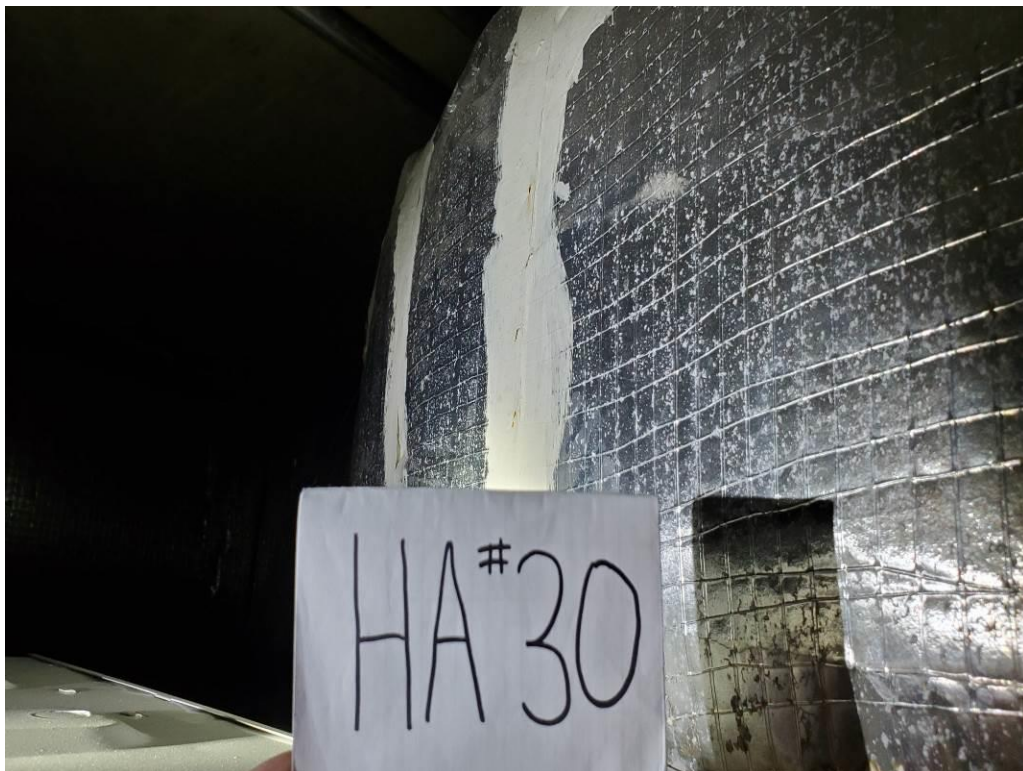
HA #30 – White Duct Insulation Mastic

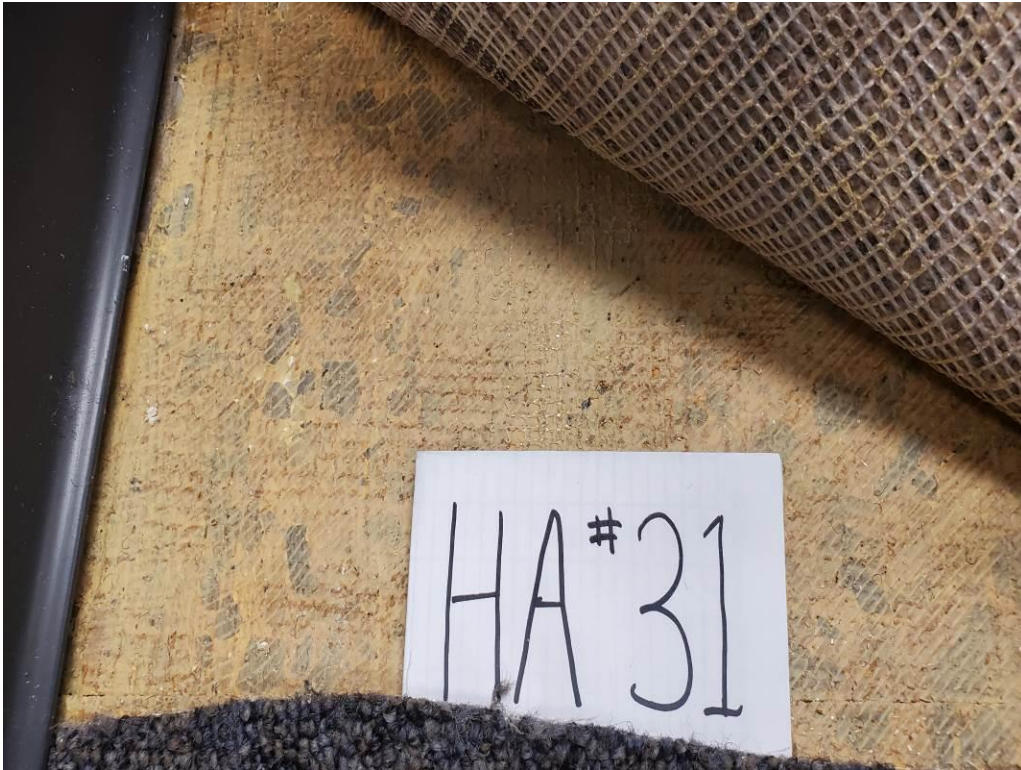
HA #31 – 12”x12” Marble Pattern Flooring VFT & Mastic

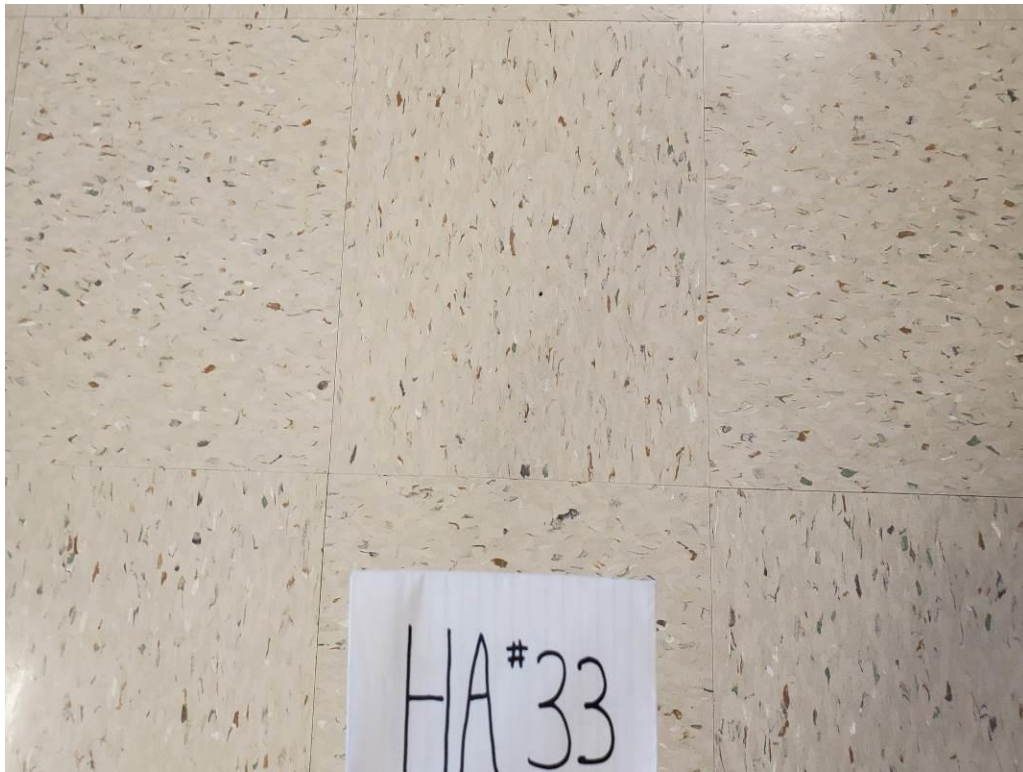
HA #33 – 12”x12” Tan w/ Brown & Green Specks VFT & Mastic
