**OFFICE OF PROCUREMENT
CONSTRUCTION MANAGER AT RISK FOR THE MACKLIN TOWER (MT) LIBRARY RENOVATION, ROCKVILLE CAMPUS
RFP NO.: 625-004
RFP CLOSING DATE AND TIME: SEPTEMBER 24, 2024 @ 2:00 PM**

**ADDENDUM #1
ISSUED: SEPTEMBER 6, 2024**

Section 5 of Appendix C: Asbestos-Containing Materials Survey for the Gordon & Marilyn Macklin Tower (Library), Rockville Campus, Final Report dated July 2, 2021

ASBESTOS-CONTAINING MATERIALS SURVEY

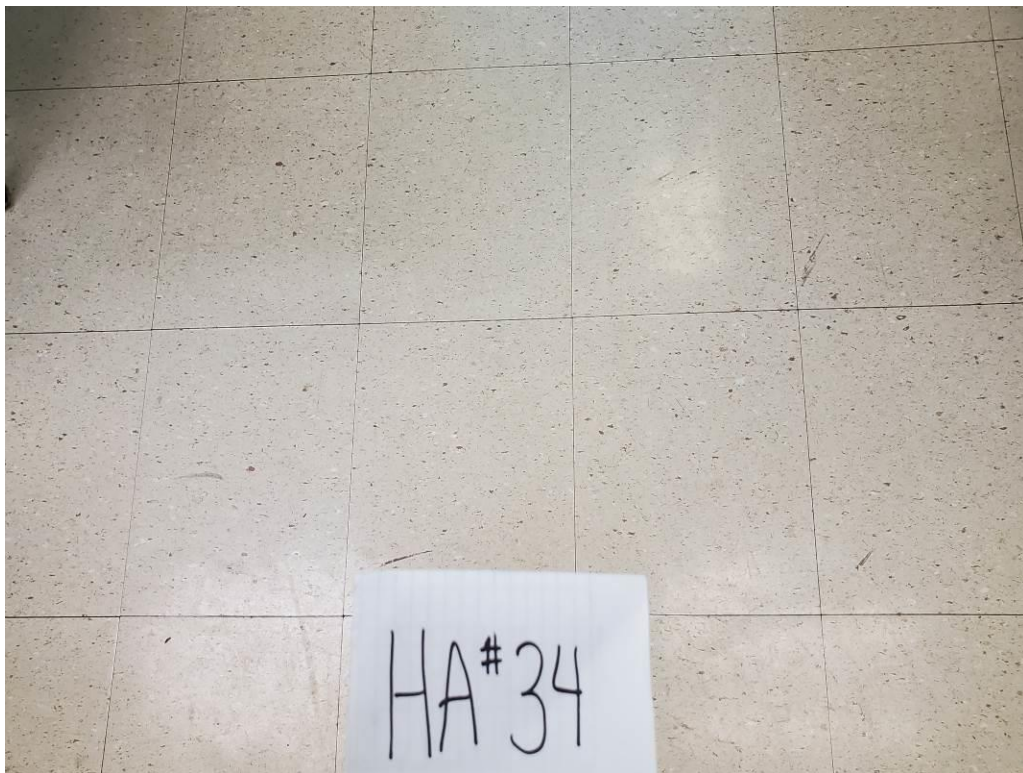
HA #34 – 12”x12” Tan w/ Brow & Green Specks VFT & Mastic

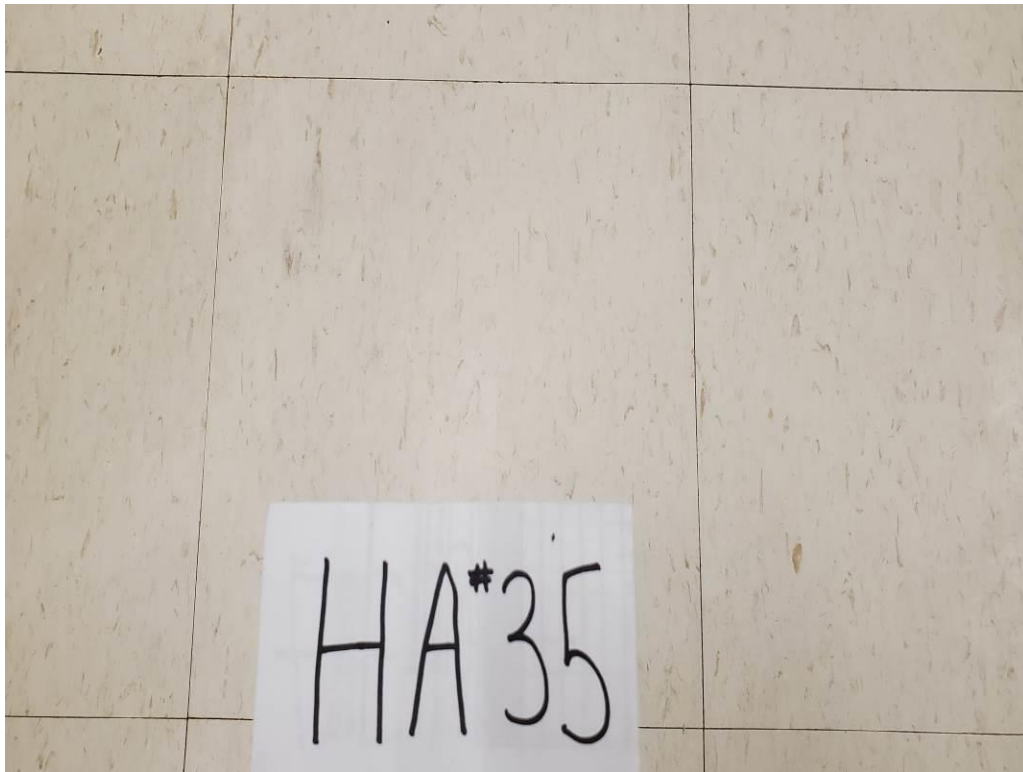
HA #35 – 12”x12” Off-White w/ Tan Specks VFT & Mastic

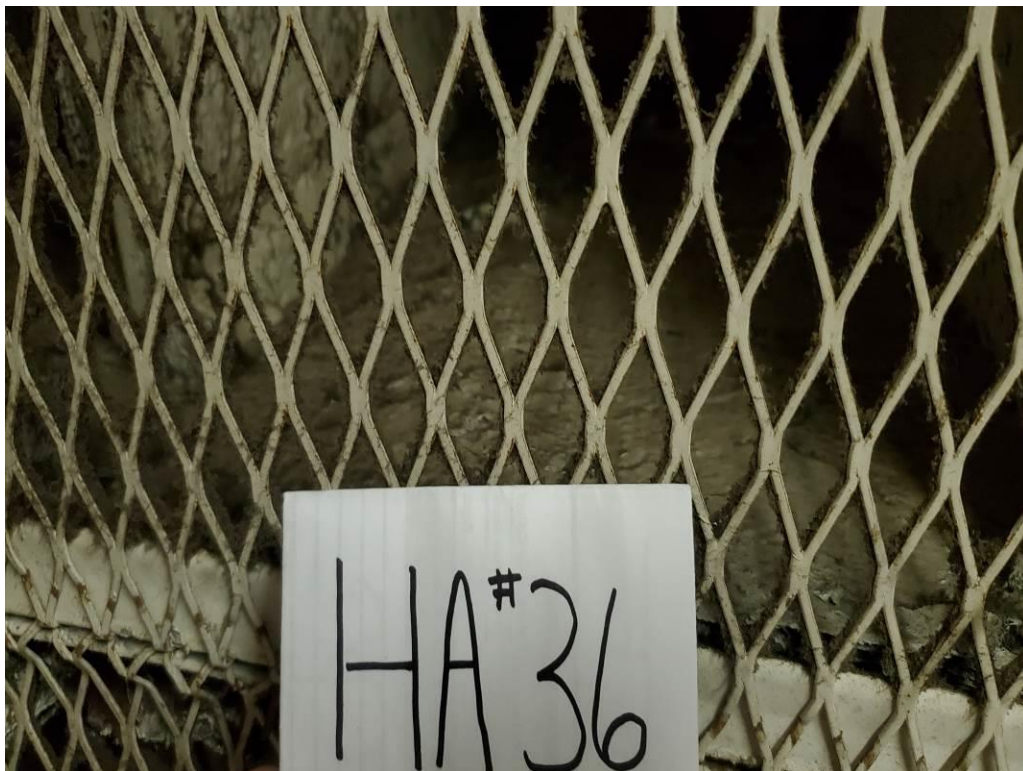
HA #36 – White Interior Duct Insulation

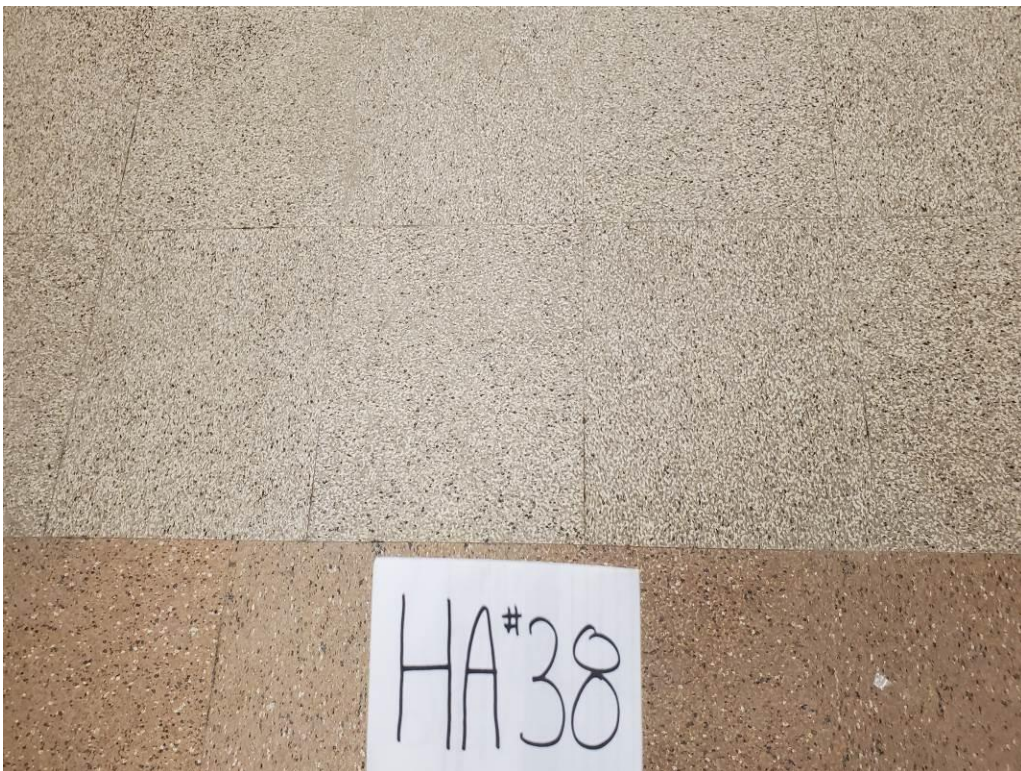
HA # 38 – 12"x12" Gray/ Orange w/ Black Spots VFT & Mastic

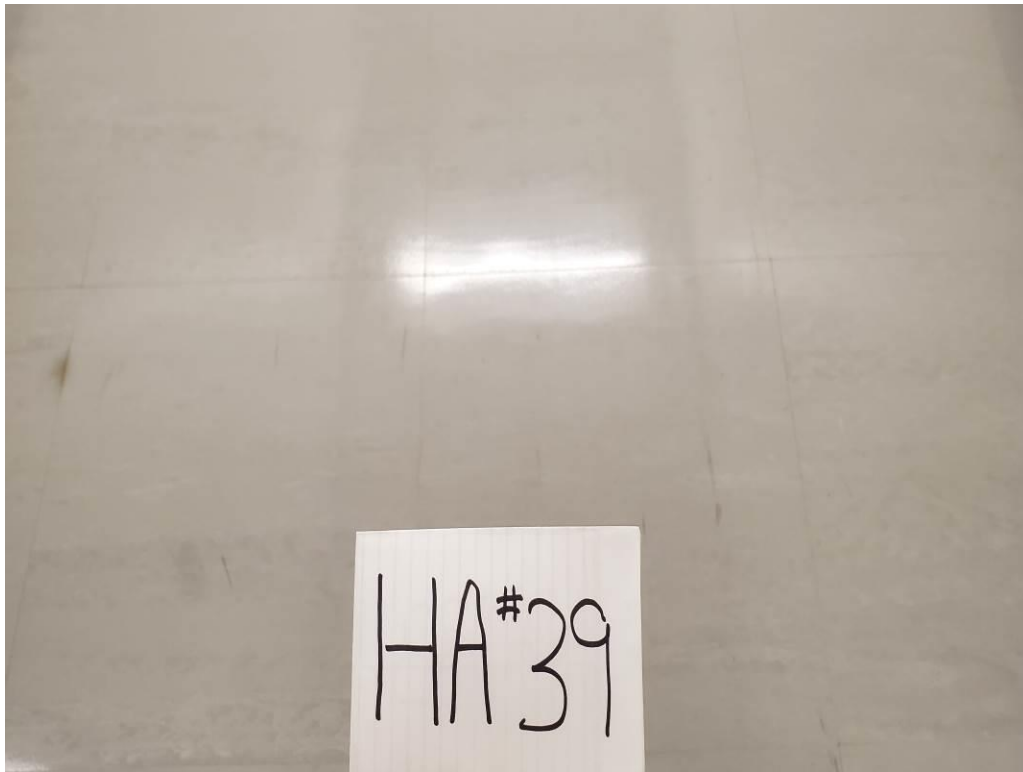
HA #39 – 18”x18” Gray VFT & Mastic

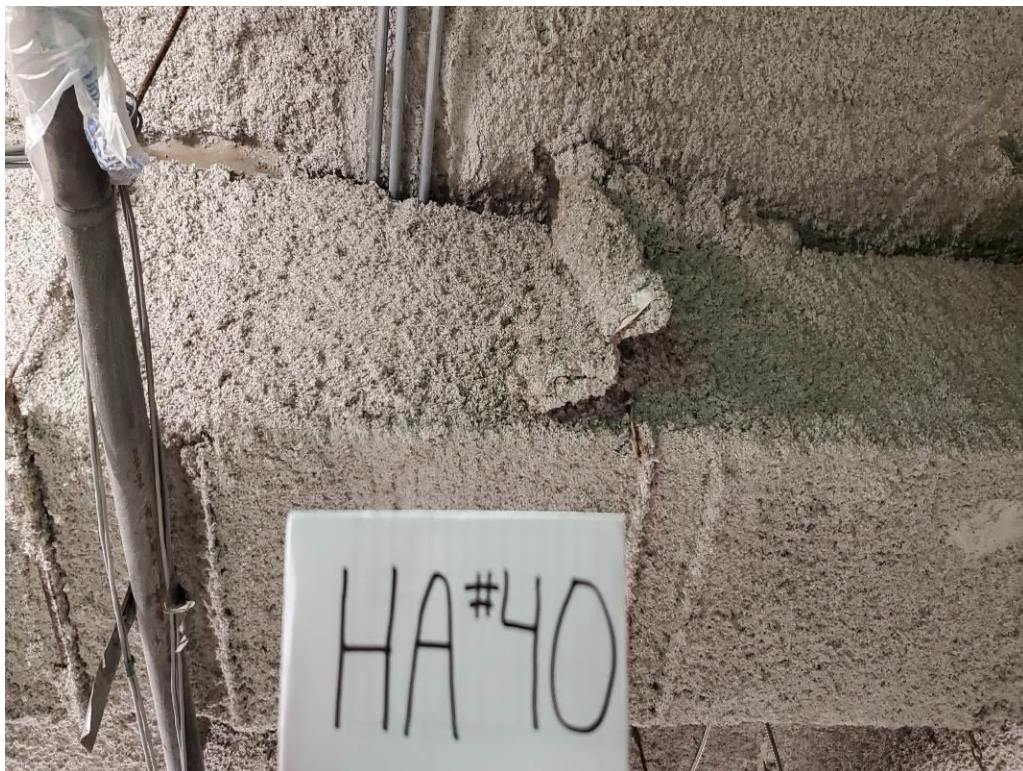
HA #40 – Gray Spray Applied Fireproofing

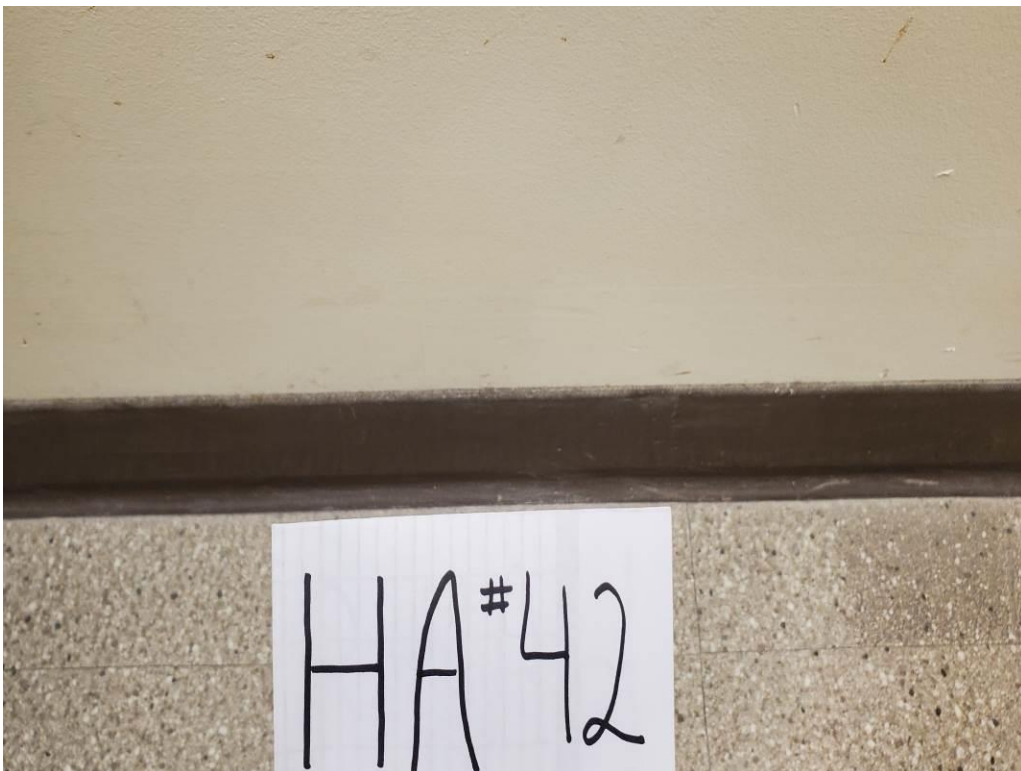
HA #42 – Brown Vinyl Cove Base w/ Mastic

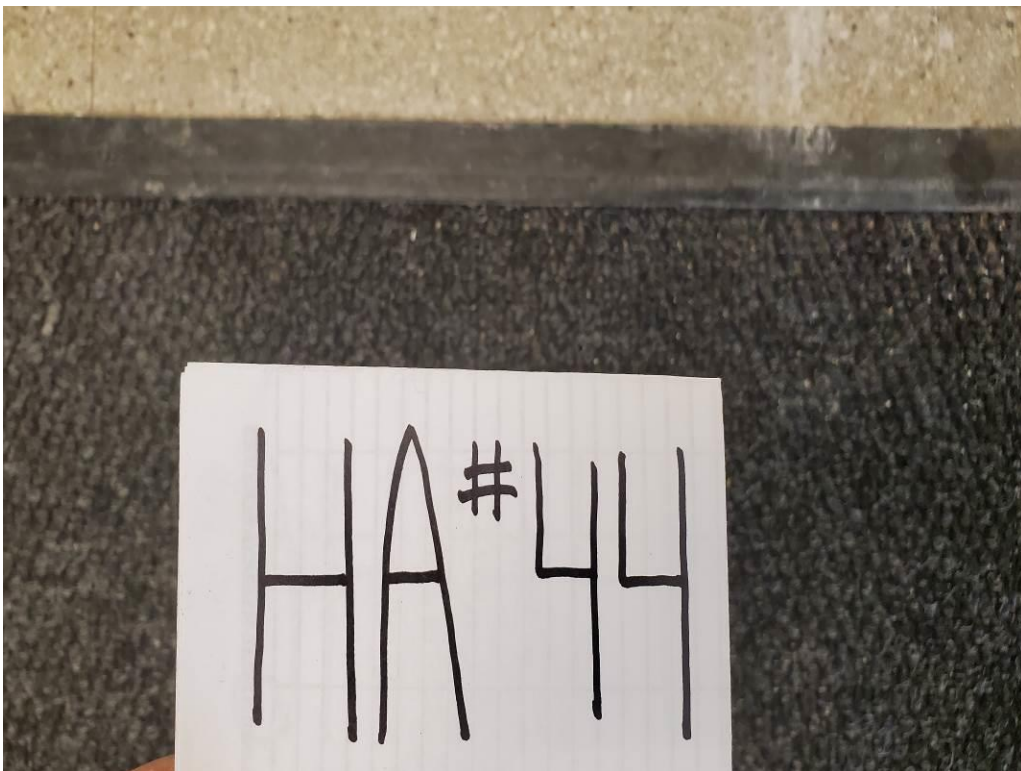
HA #44 – Black Vinyl Threshold Strip

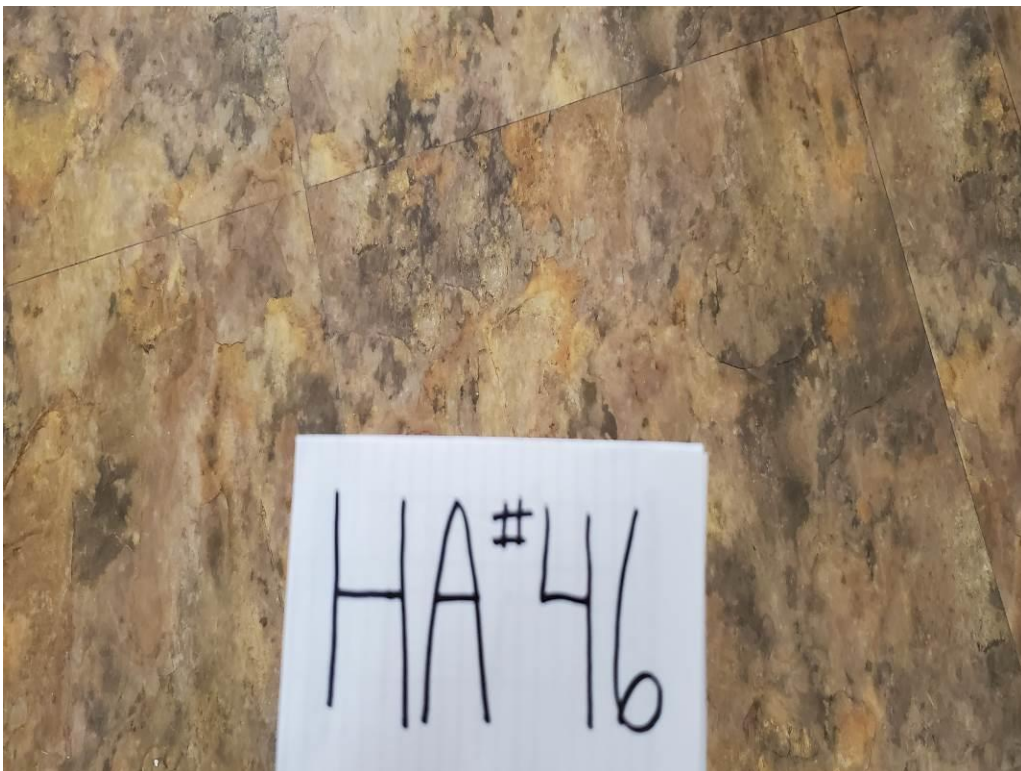
HA #46 – 18”x18” Marble Pattern VFT & Mastic

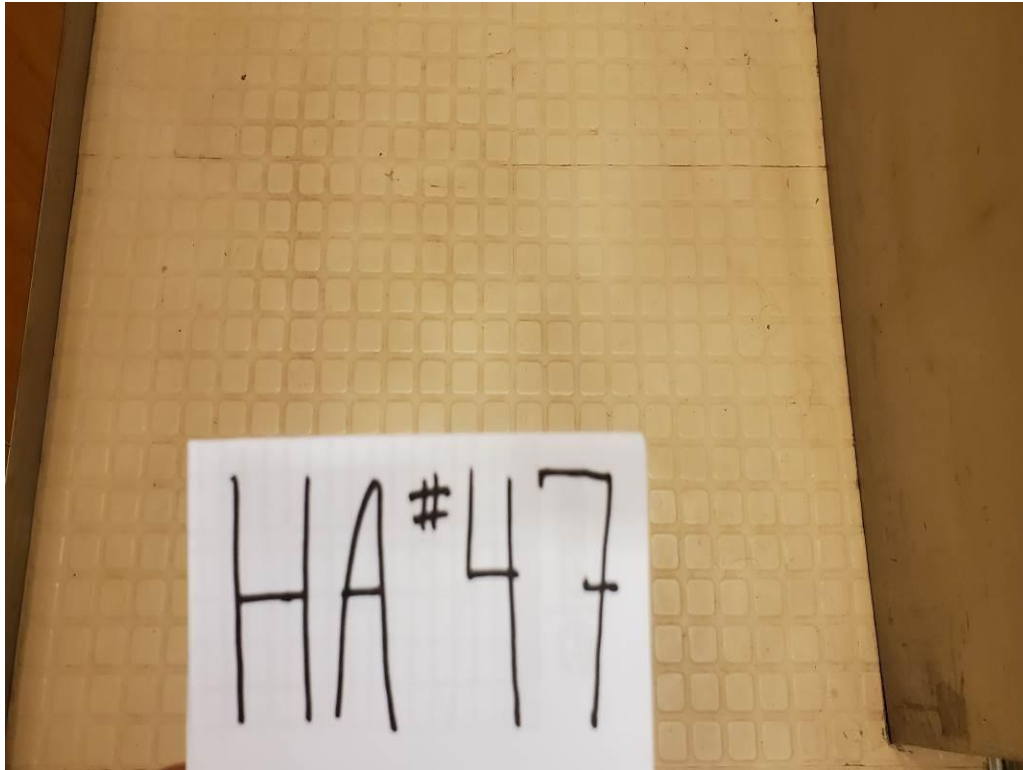
HA #47 – Yellow Textured VFT & Mastic

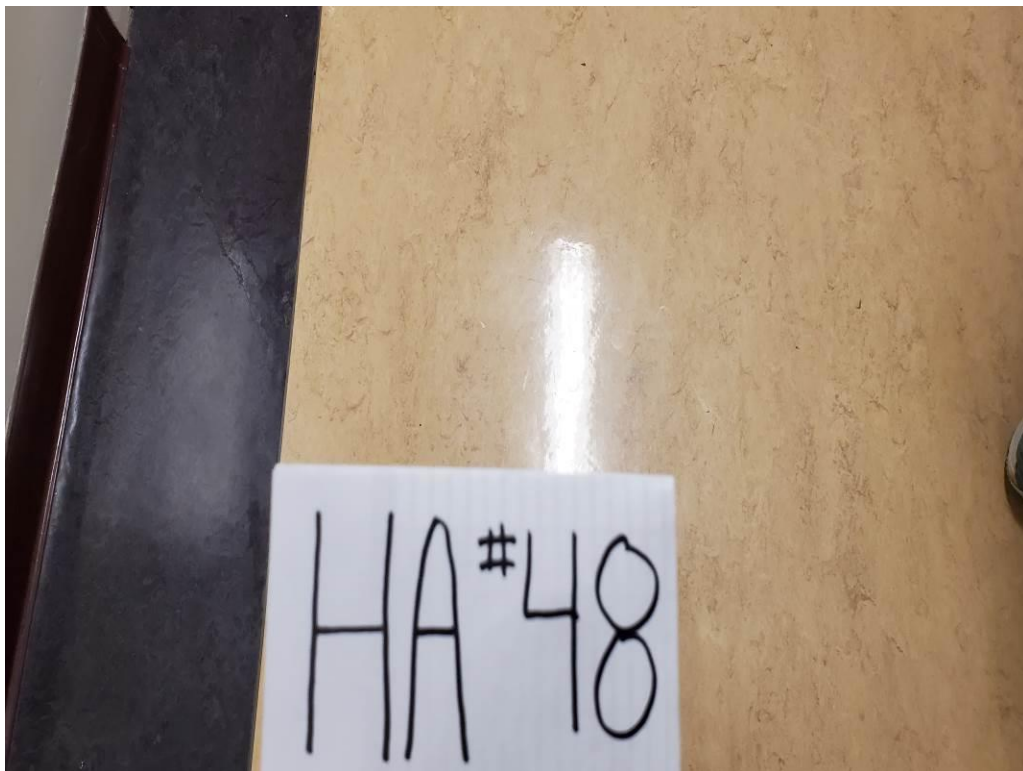
HA #48 – Purple & Orange VSG & Mastic

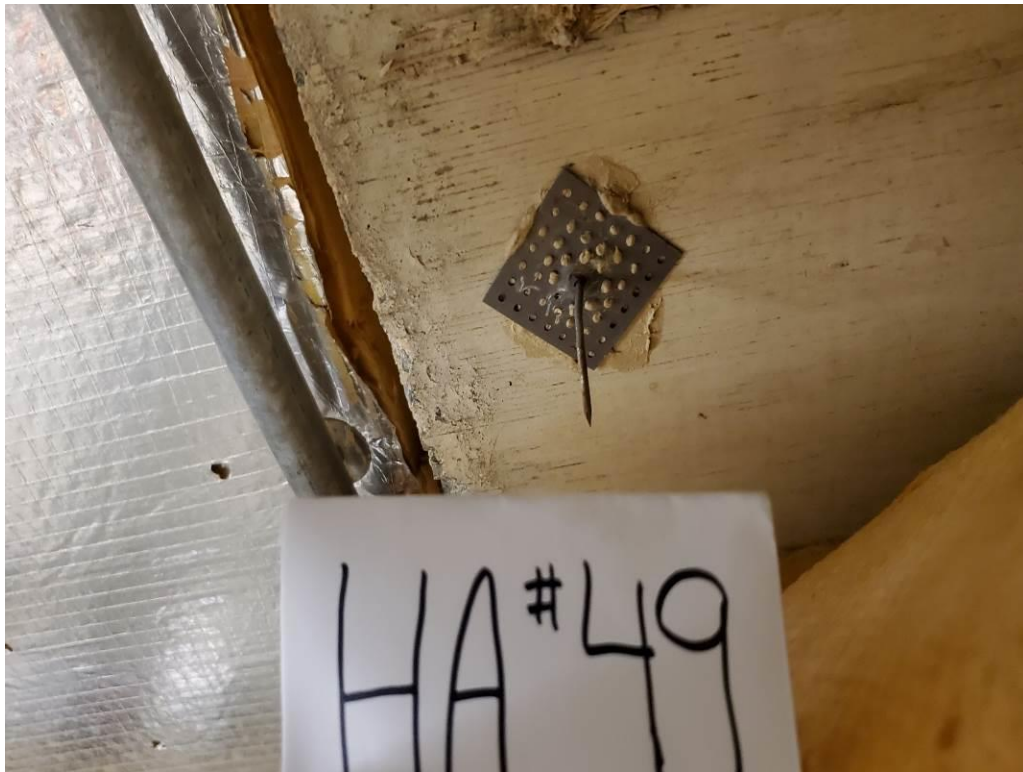
HA #49 – Tan Ceiling Insulation Pin Mastic

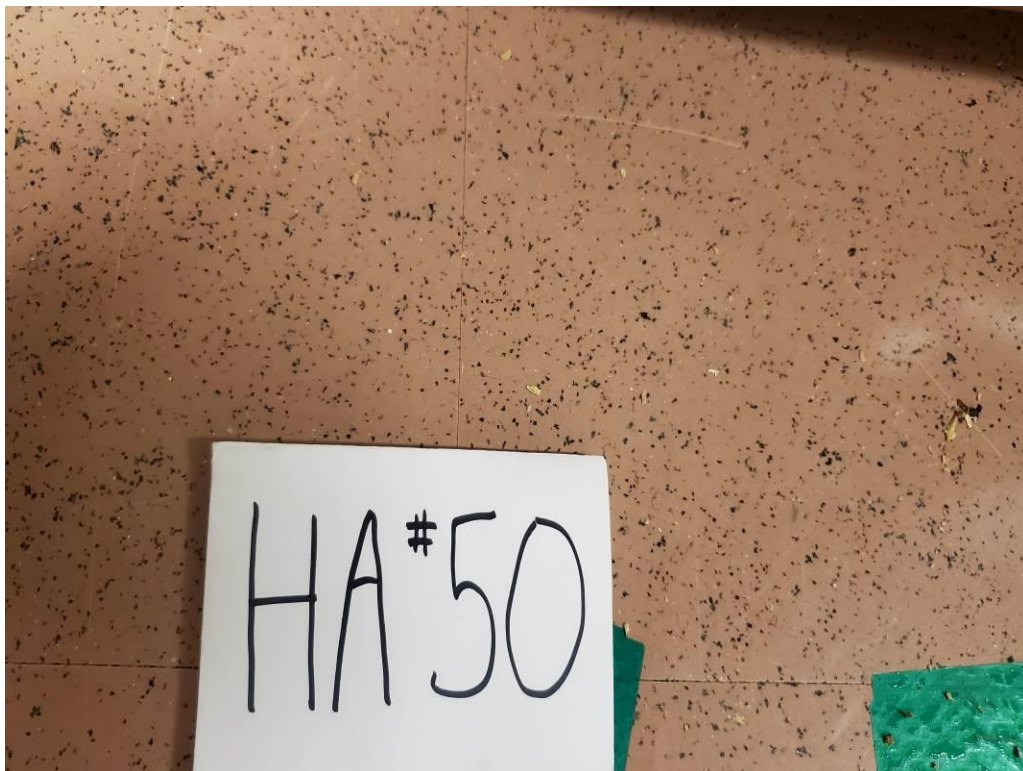
HA #50 – 12"x12" Pink w/ Black Spots VFt & Mastic

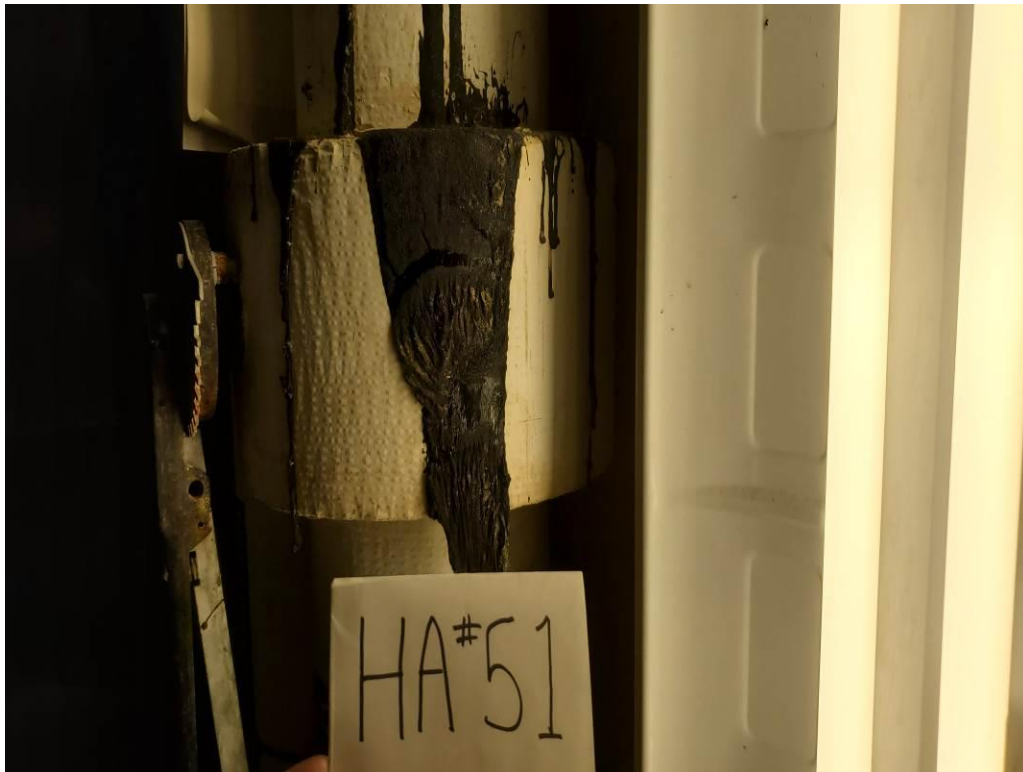
HA #51 – Black Tar Sealant

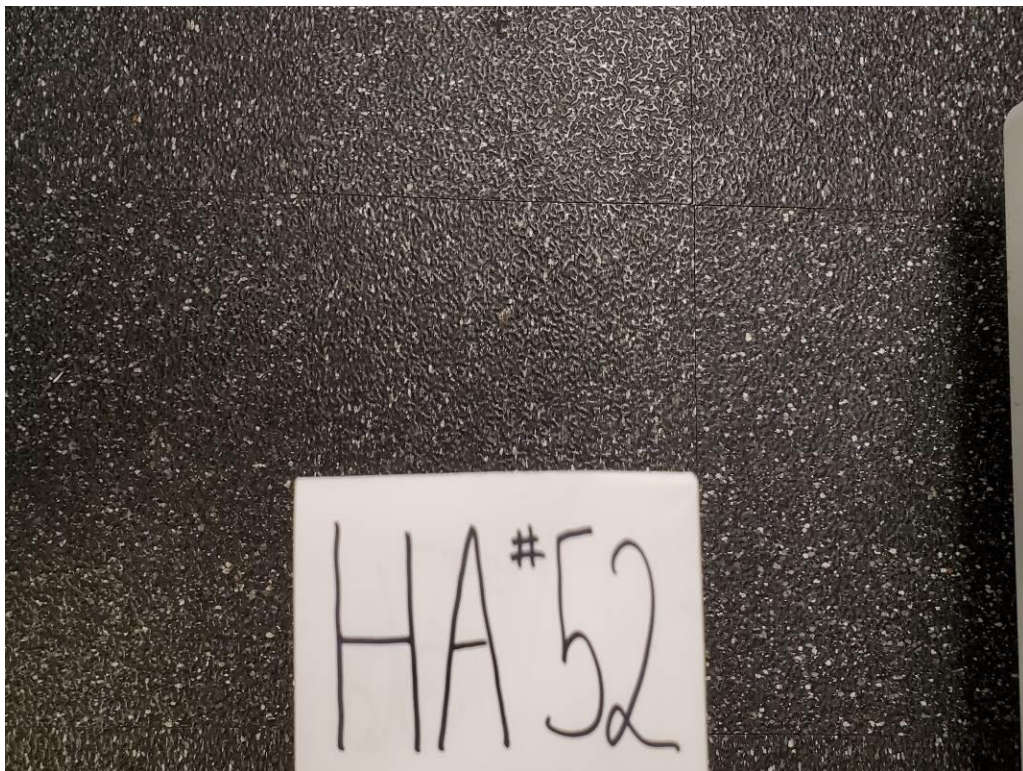
HA #52 – 12"x12" Black w/ White Spots VFT & Mastic

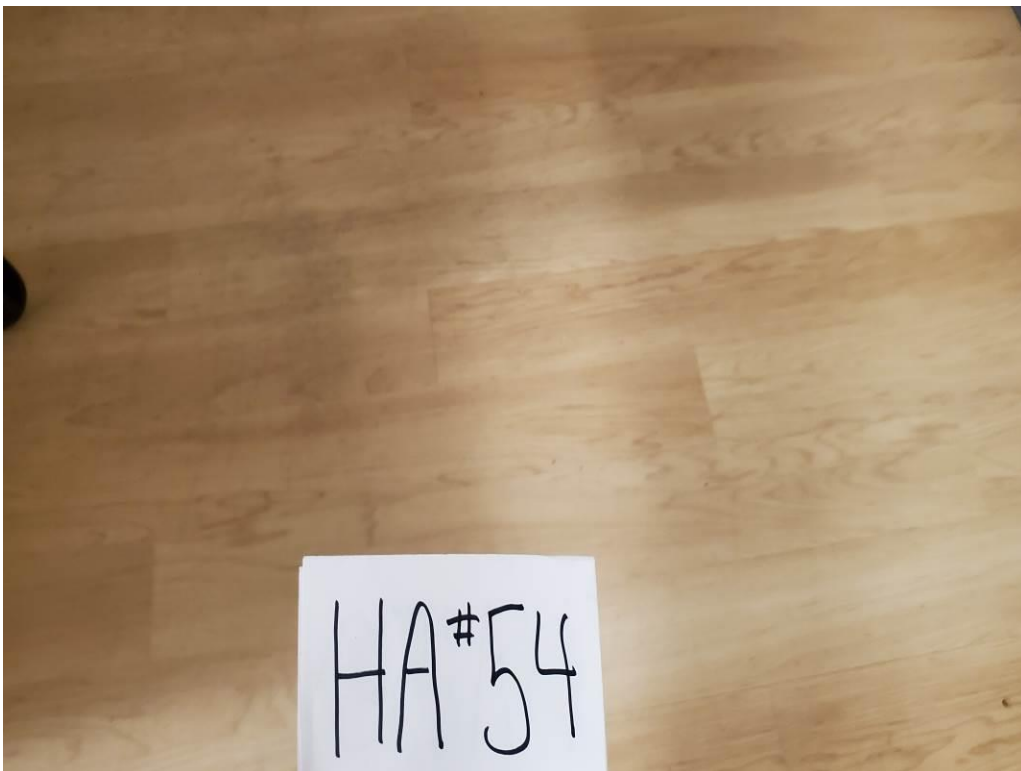
HA #54 – Wood Pattern VSG & Mastic

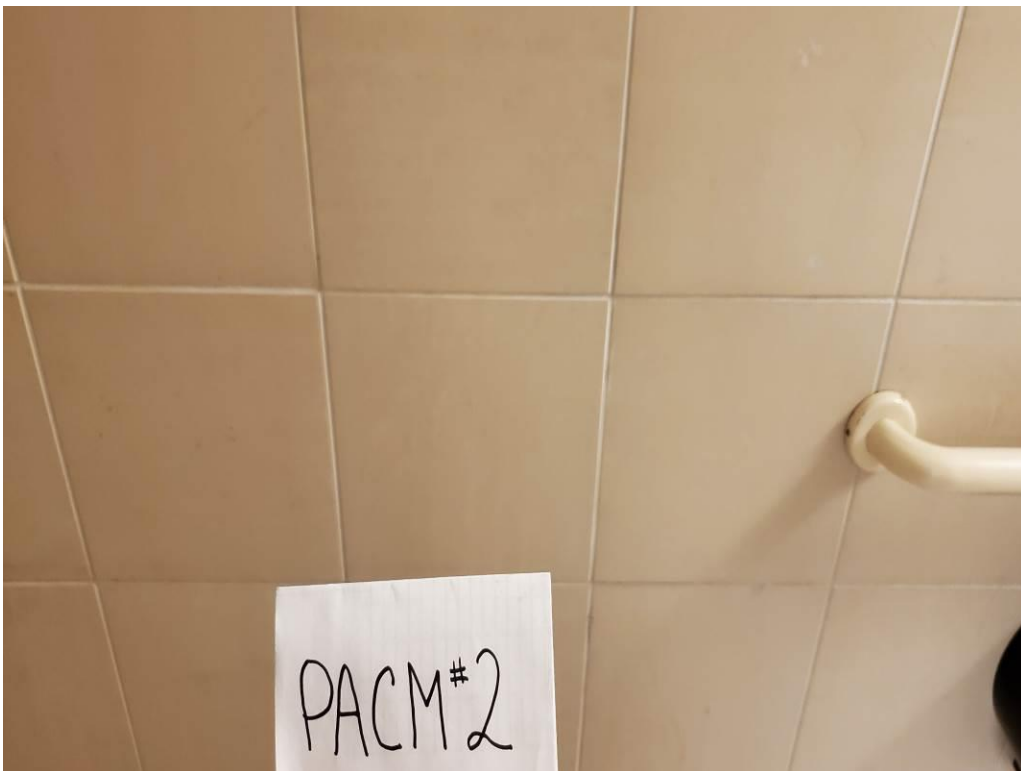
PACM #2 – 12”x12” Tan Ceramic Wall Tile Grout & Adhesive

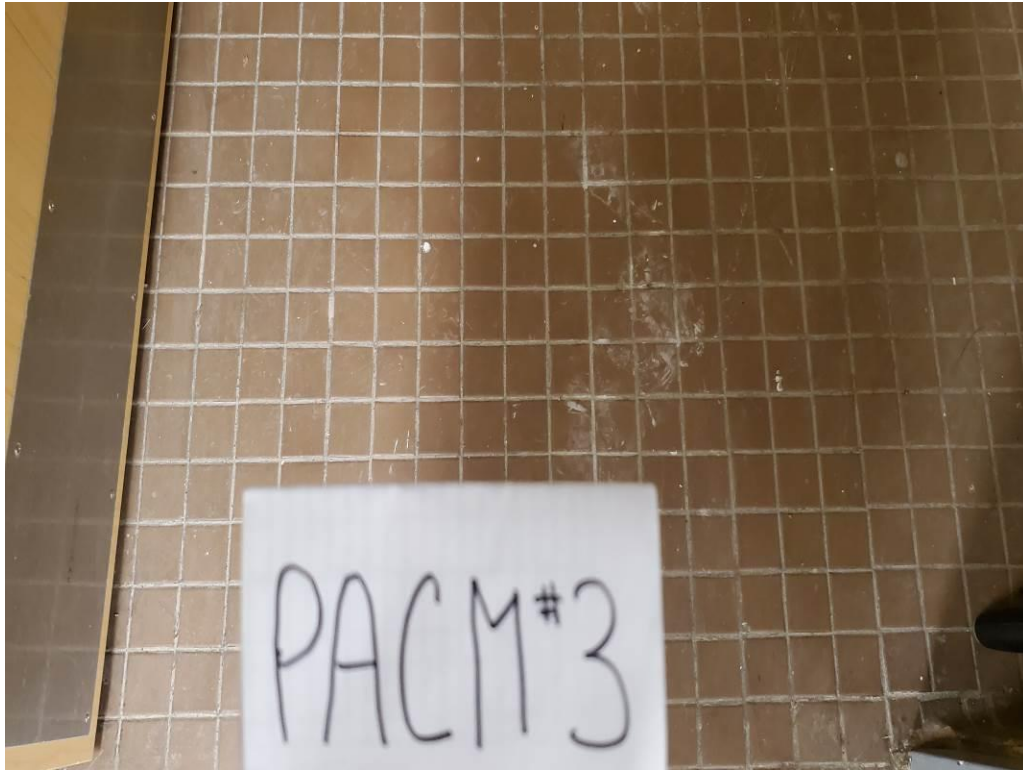
PACM #3 – 1”x1” Brown Ceramic Floor Tile Grout & Thinset

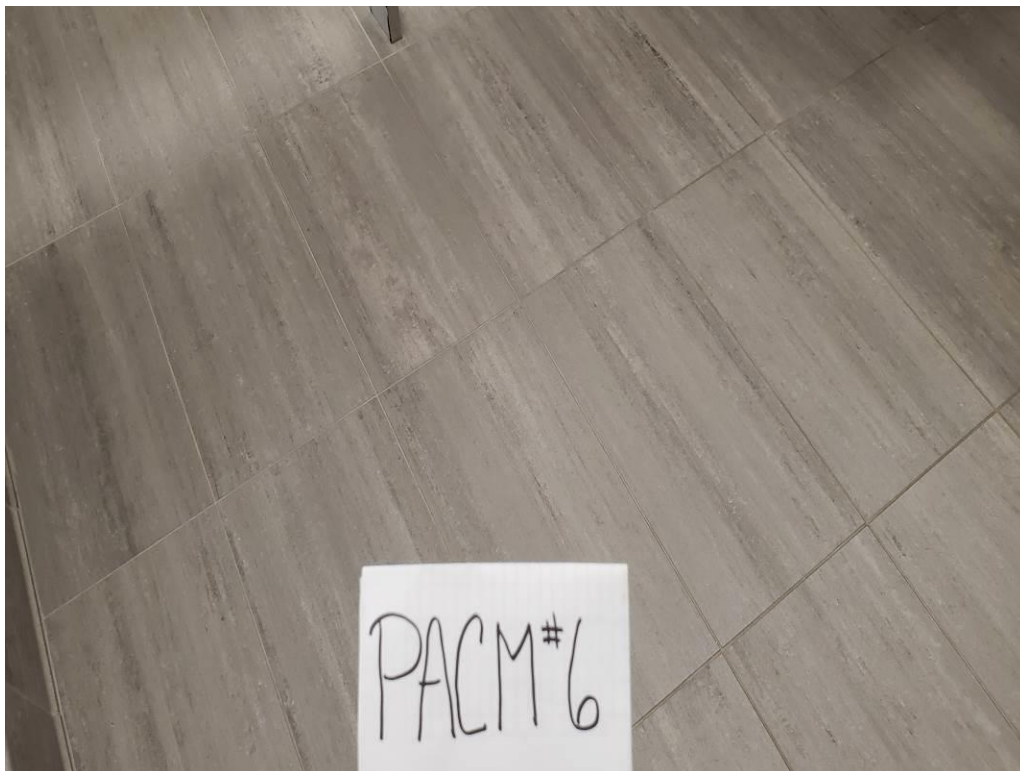
PACM #6 – Gray Ceramic Floor & Wall Tile Grout & Adhesive

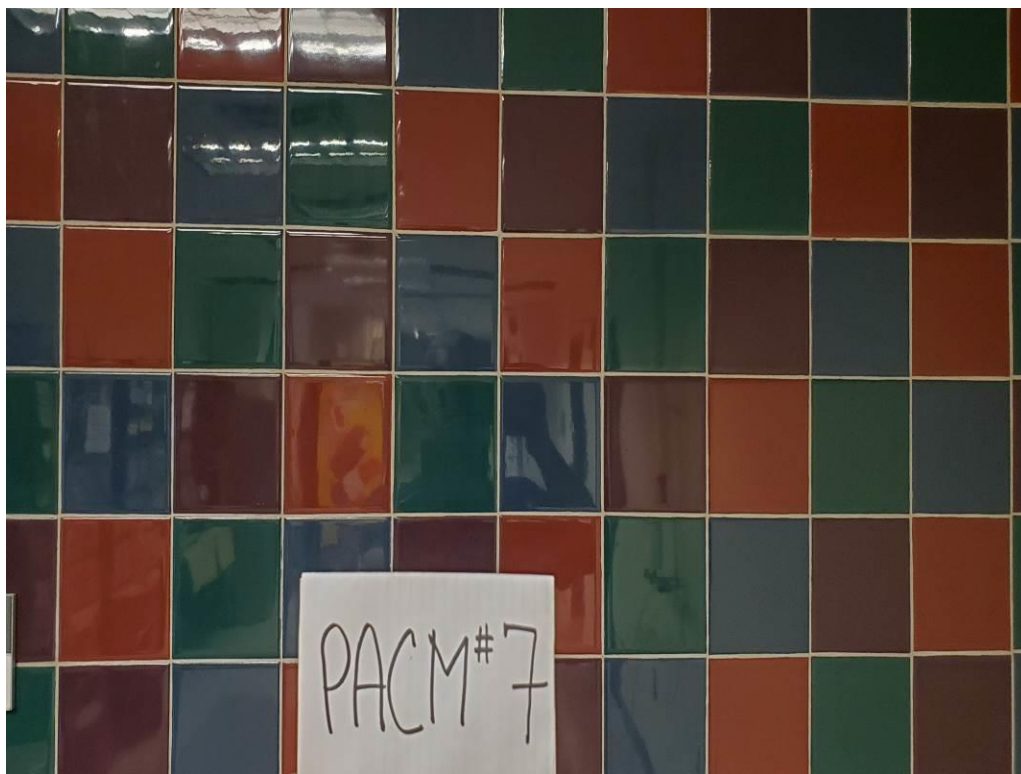
PACM #7 – Multicolor Ceramic Wall Tile Grout & Adhesive
