**OFFICE OF PROCUREMENT
CONSTRUCTION MANAGER AT RISK FOR THE MACKLIN TOWER (MT) LIBRARY RENOVATION, ROCKVILLE CAMPUS
RFP NO.: 625-004
RFP CLOSING DATE AND TIME: SEPTEMBER 24, 2024 @ 2:00 PM**

**ADDENDUM #1
ISSUED: SEPTEMBER 6, 2024**

Section 5 of Appendix C: Asbestos-Containing Materials Survey for the Gordon & Marilyn Macklin Tower (Library), Rockville Campus, Final Report dated July 2, 2021

ASBESTOS-CONTAINING MATERIALS SURVEY

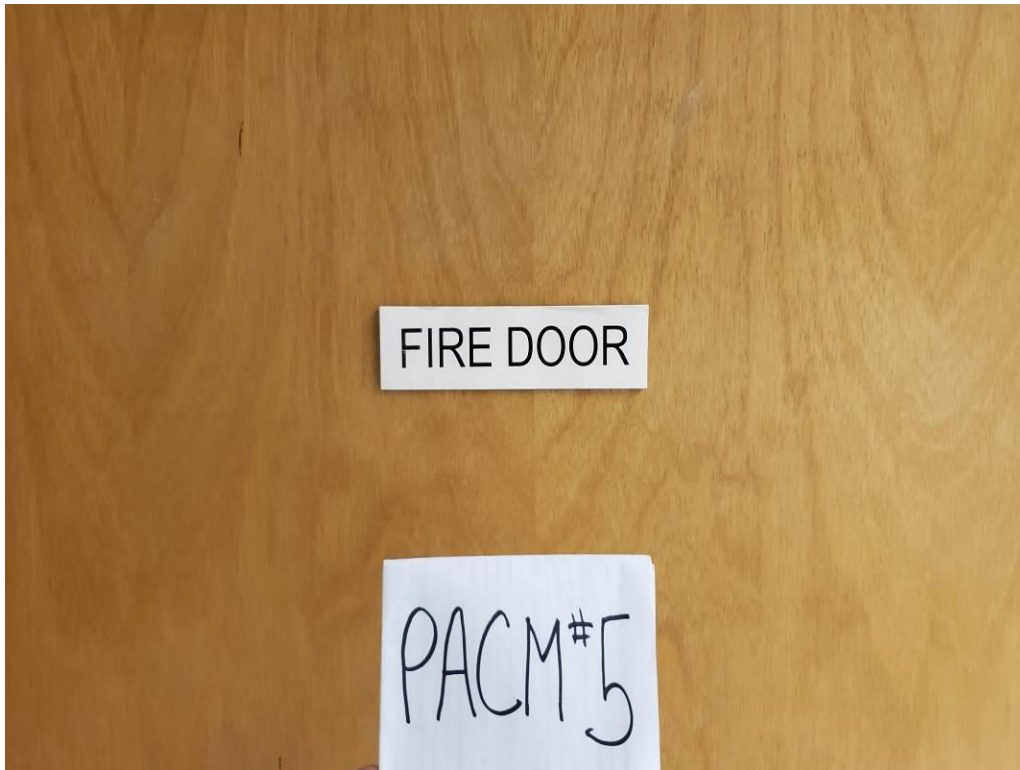
PACM #5 – Fire Door
